## FACILITY NEEDS ASSESSMENT

### ESSEX ELEMENTARY SCHOOL AND MANCHESTER ESSEX MIDDLE-HIGH SCHOOL

#### Manchester Essex Regional School District

DRAFT REPORT: January 27, 2023  
H&A JN 2217.01

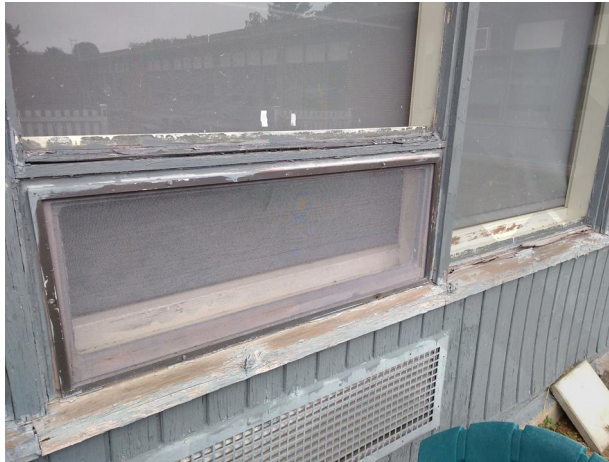
2. Original windows and trim have deteriorated.

| Work Item Description | Year Inst. | Qty | Unit | Unit Cost | Total | <sup>1</sup> Total w/ Soft Costs | Scope 1 | Scope 2 | Scope 3 | Totals |
|---|---|---|---|---|---|---|---|---|---|---|
| <b>2.4</b> Entire window system is past its useful lifespan and thermally inefficient - Replace entire window system throughout school. Some windows are single pane, while others are dual pane but have no thermal break and many have condensation. Wood trim and sills of the original building are rotted. Newer sills are incorrectly installed and do not correctly shed water. There are reports that building is uncomfortably cold and drafty during the winter. | 1957<br>1975 | 5,800 | SF | 200.00 | 1,160,000 | 1,508,000 | 1,508,000 | | | 1,508,000 |

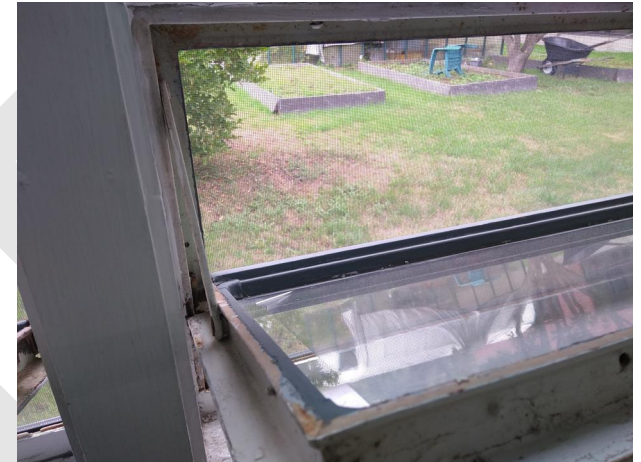
3. Operable steel hopper window has no weather strip.

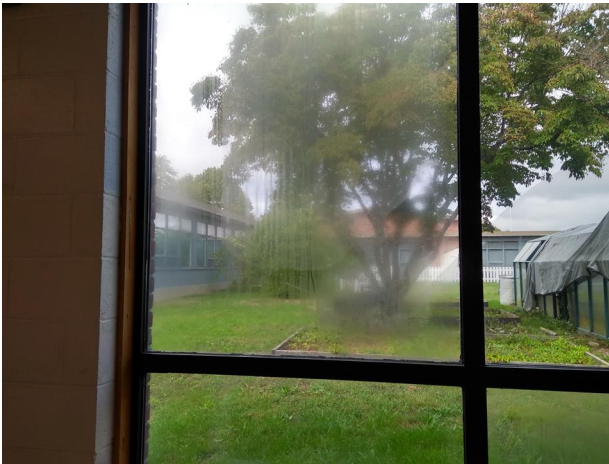
4. Thermal pane window has seal failure.

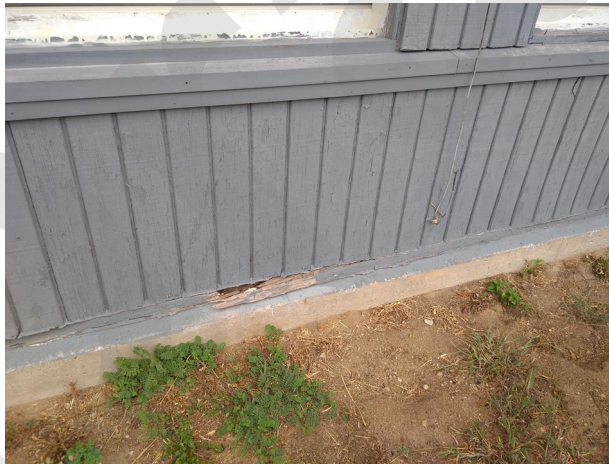
5. The wood siding is rotted and damaged.

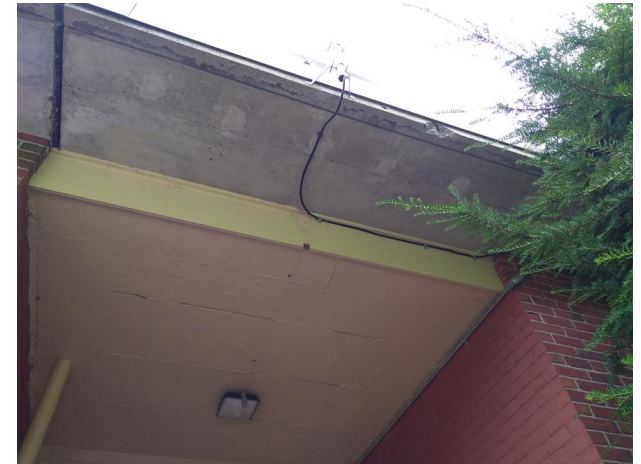
6. The concrete facias and soffits have spalled.

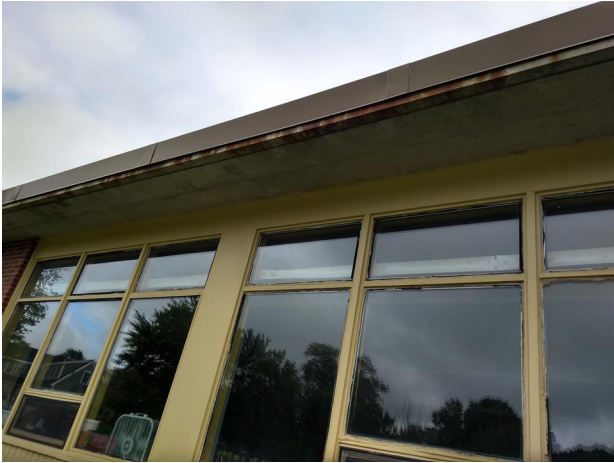
7. Original roof soffits have corroded.

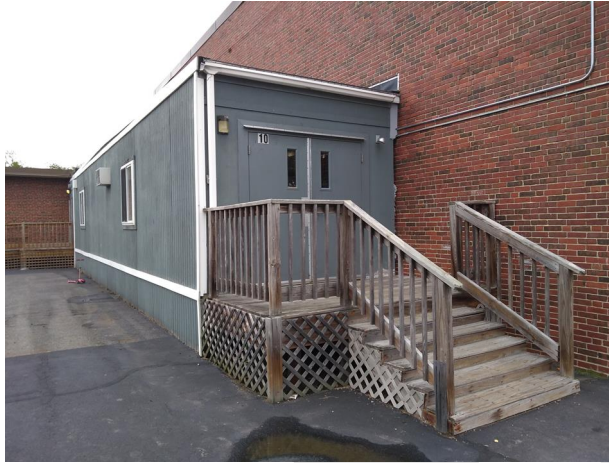
8. Modular addition has deteriorated and leaks at connection to main building.

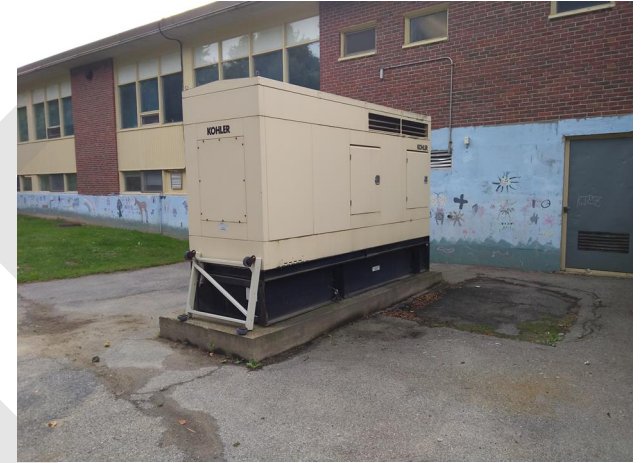
9. Confirm that generator has been maintained per manufacturer's recommendations.

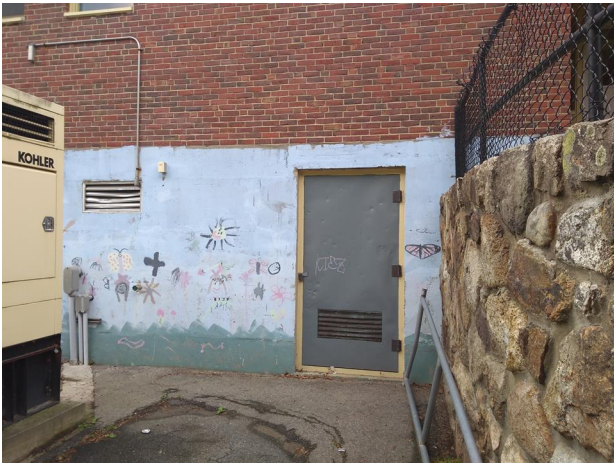
10. Bituminous pavement is damaged, original hollow metal doors require repair/replacement.

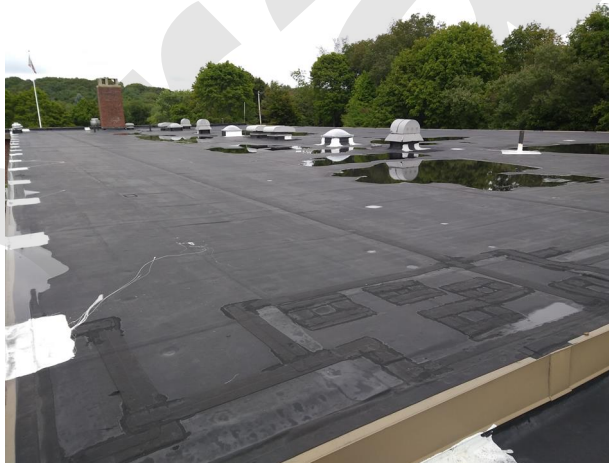
11. Rubber membrane roof has many areas of standing water and is extensively patched.

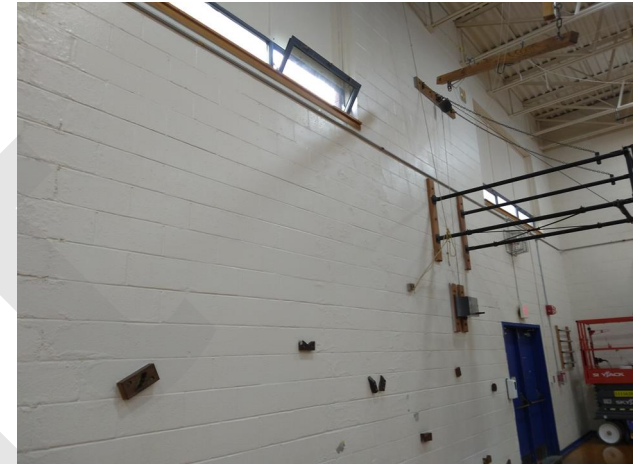
15. The brick/CMU wall of Gym shows signs of extensive water damage and is not insulated.

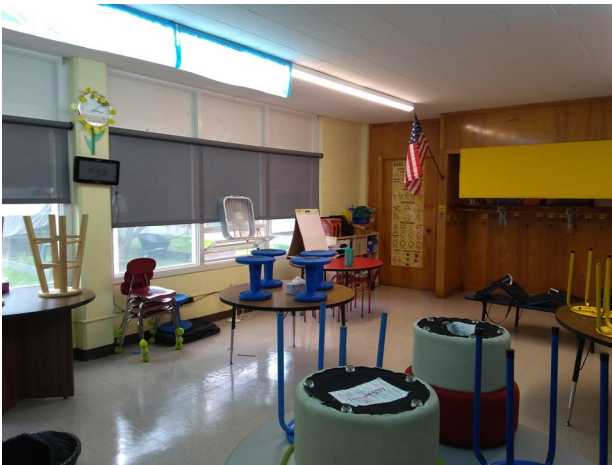
16. Classrooms have outdated spline ceiling and insufficient ventilation.

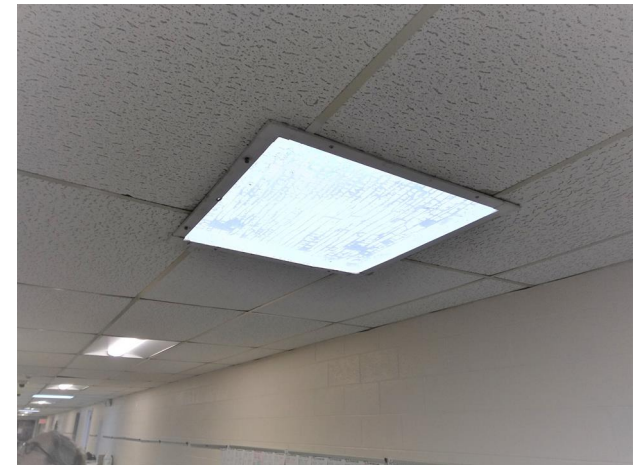
18. The skylights in the corridors are damaged.

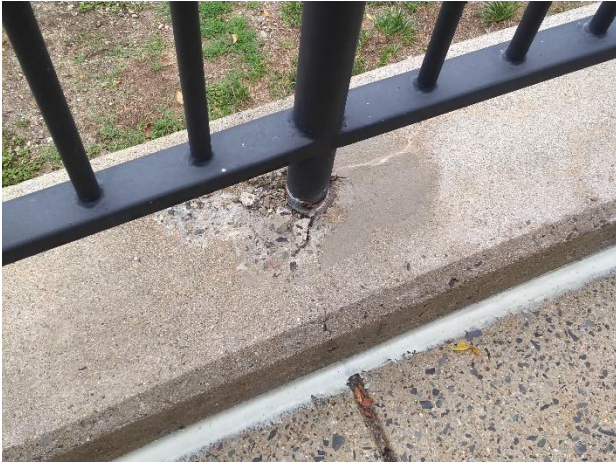
1. Concrete has spalled at some rail posts.

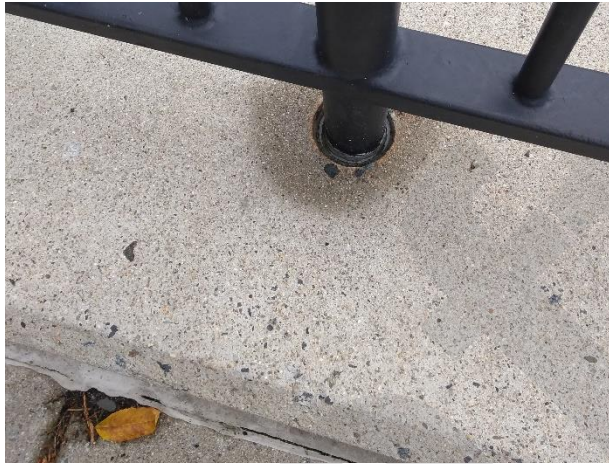
2. Rail posts do not have sealants and some sealants are failing.

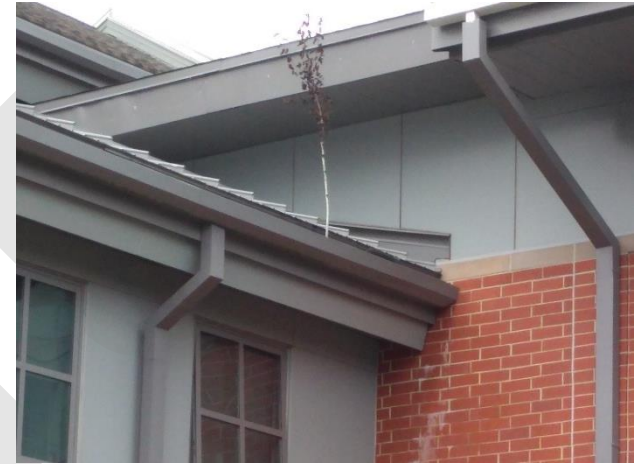
3. Some gutters are clogged with vegetation.

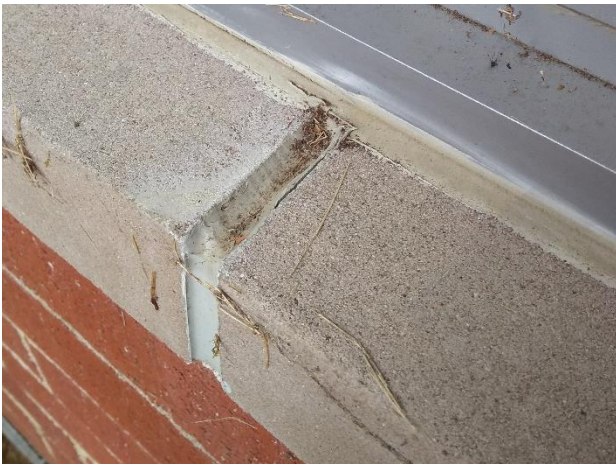
4. Some sealant shows early signs of deterioration.

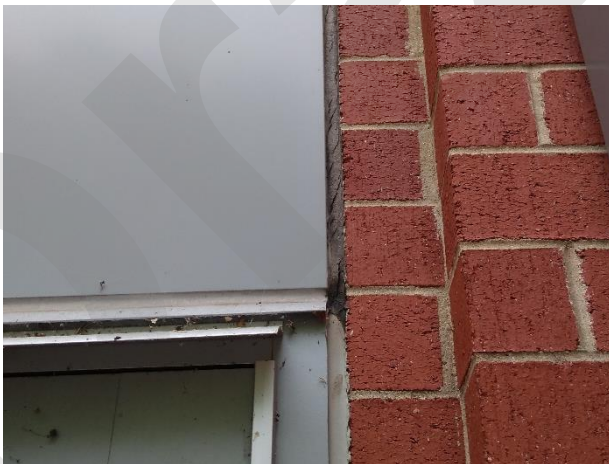
5. Sealant at metal panel is showing signs of deterioration.

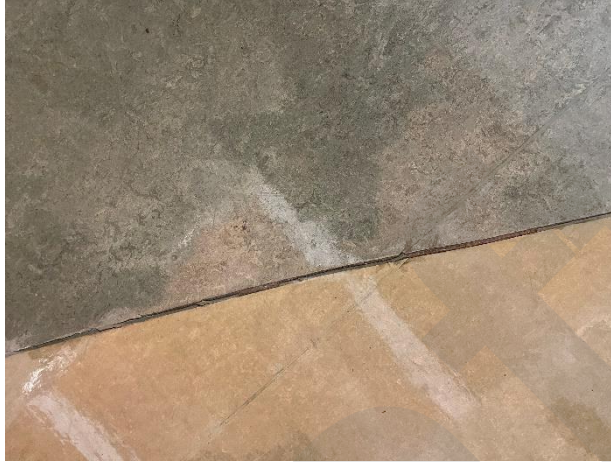
8. Some floor joints at natural linoleum are damaged.

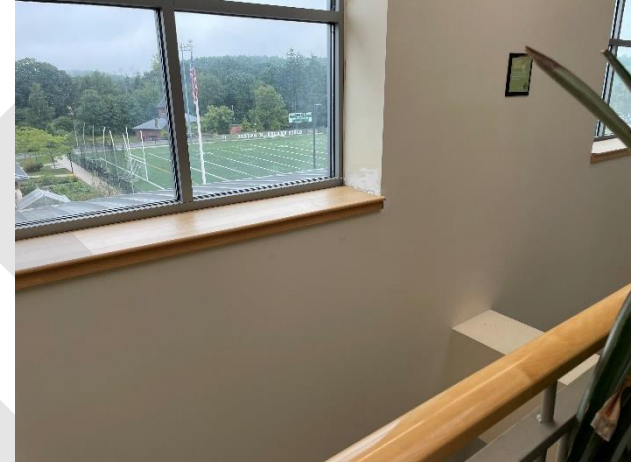
9. Several windows show signs of water damage.

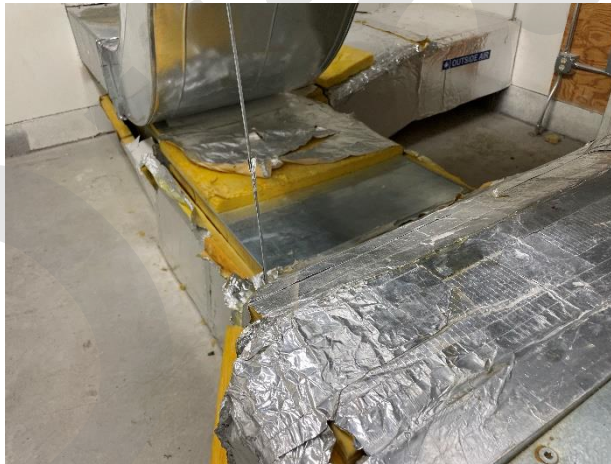
11. Some duct work has damaged or missing insulation.

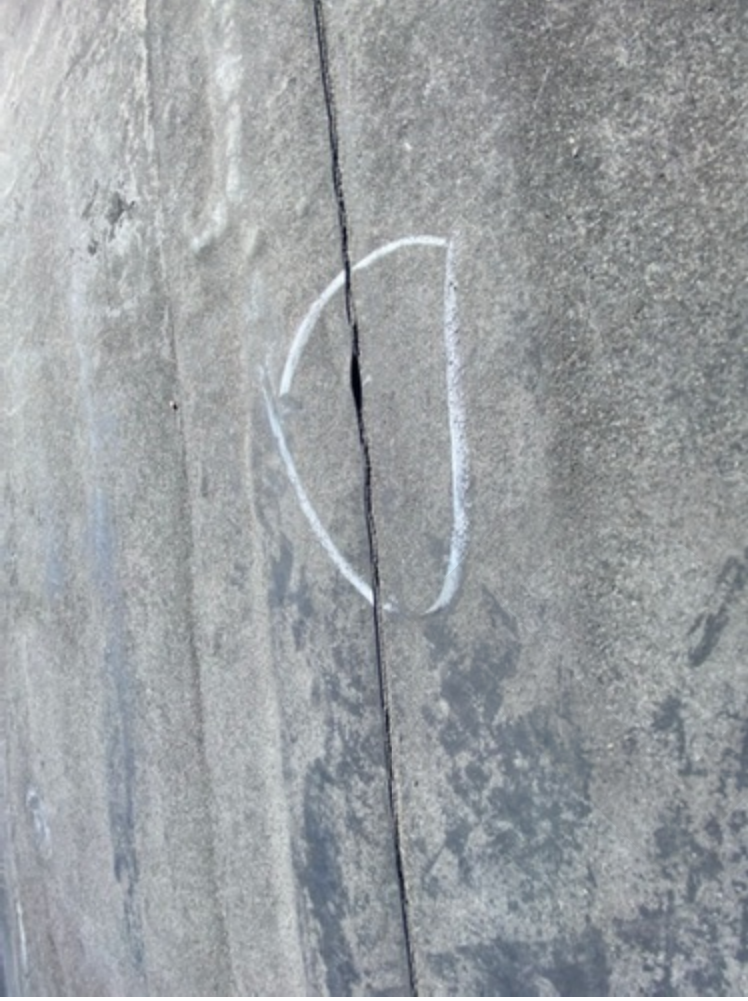
*Photo 3*

**Failed seam in ponding area.**

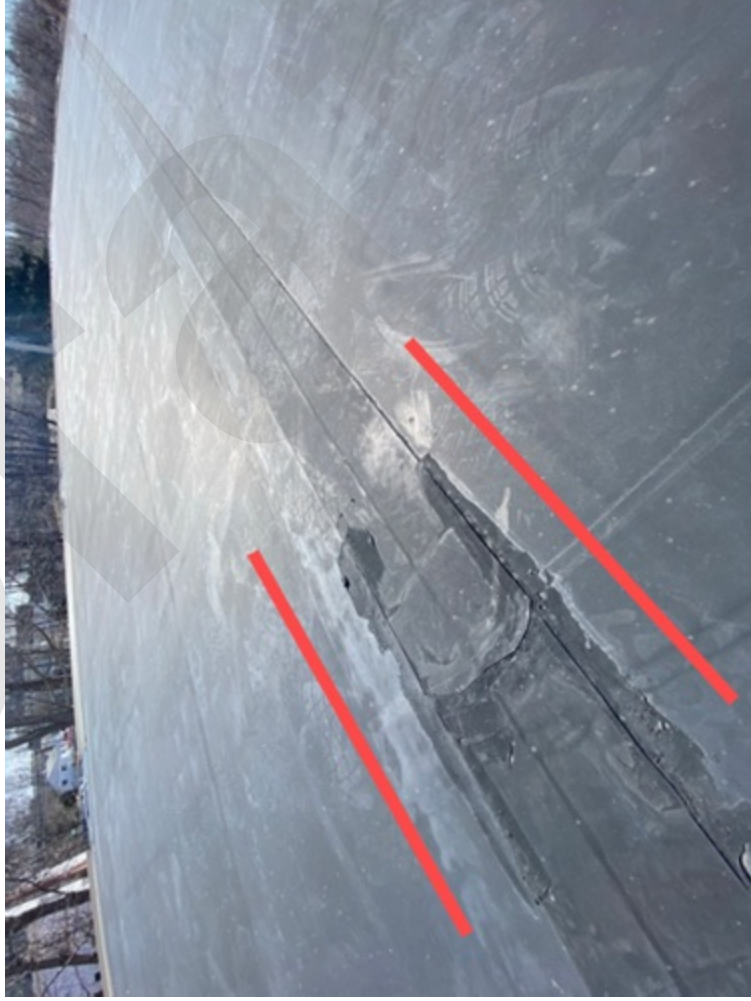
*Photo 4*

**Deteriorating coverstrip repair over seam.**

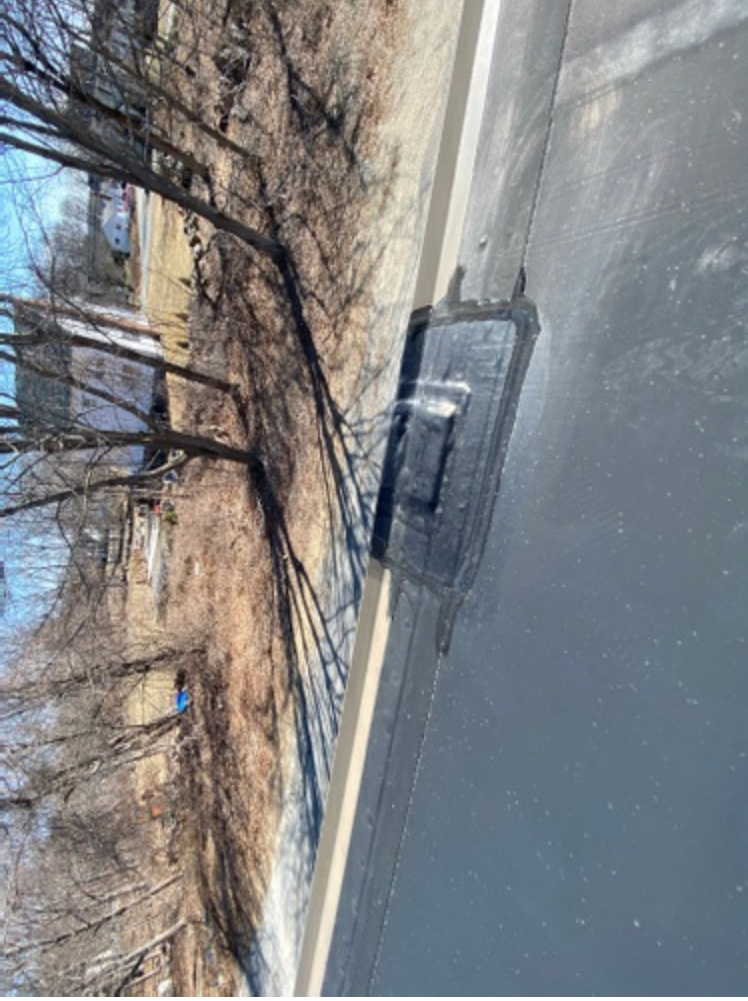
*Photo 5*

**Previously repaired open condition at lap in edge metal.**

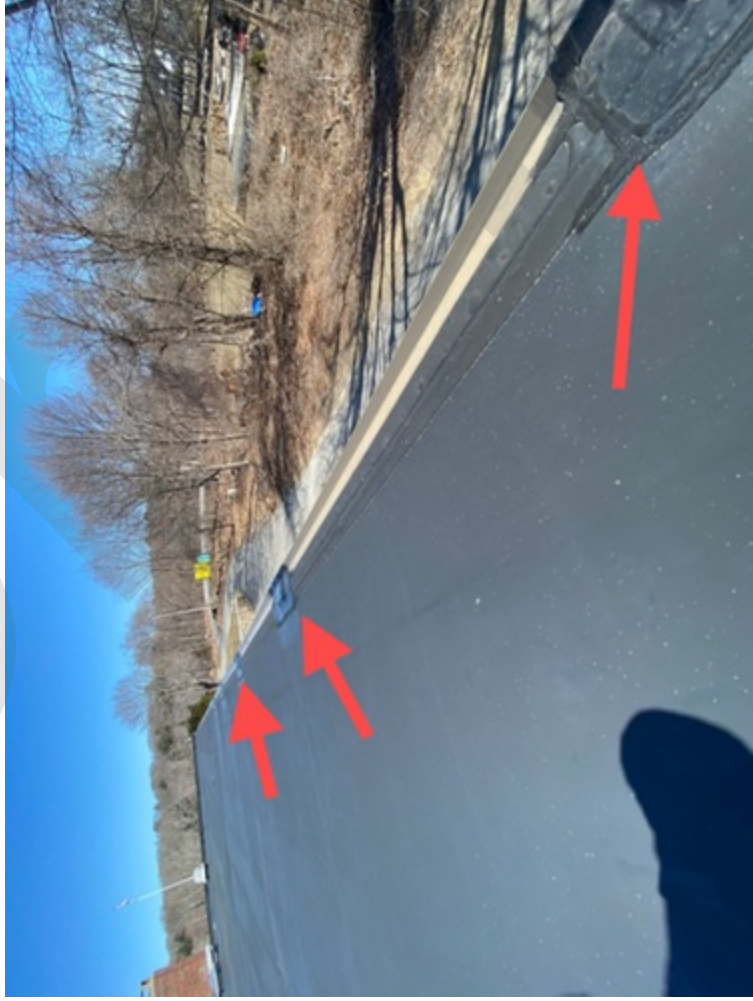
*Photo 6*

**Previously repaired laps in edge metal.**

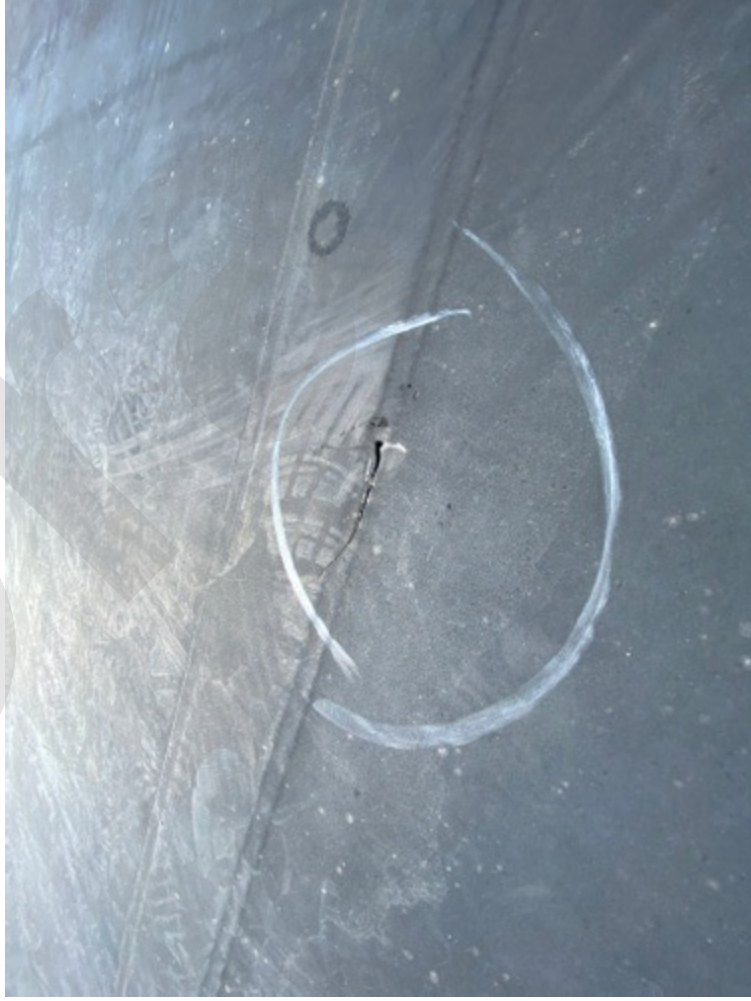
*Photo 8*

**Penetration in membrane.**  
This is a source of water infiltration to the roofing assembly.

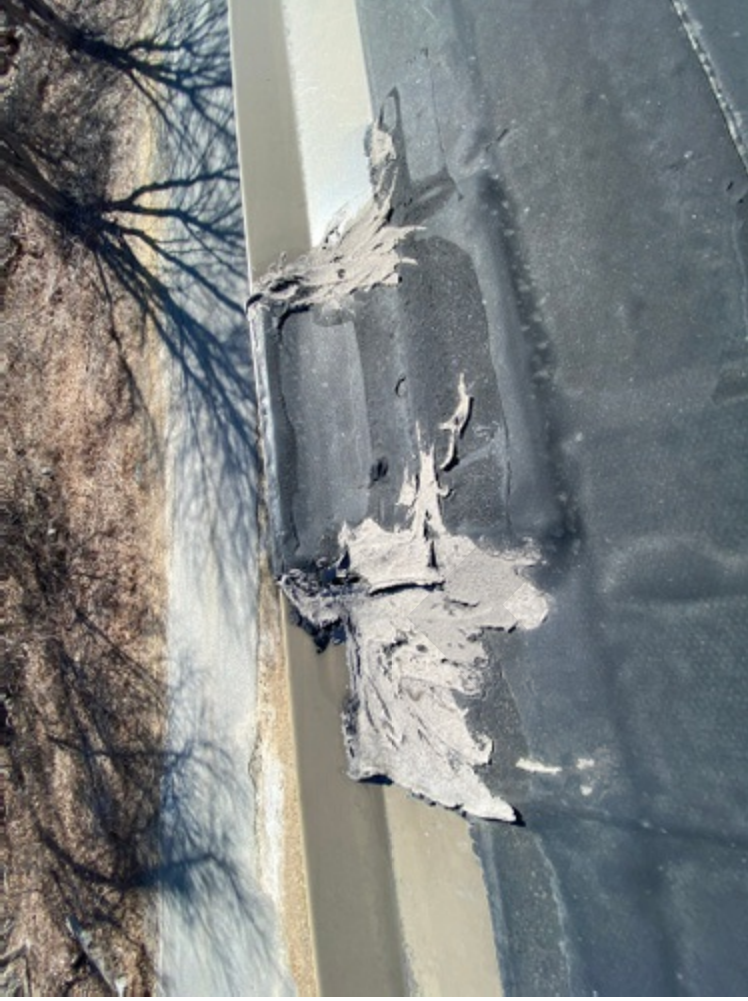
*Photo 9*

**Failed patch over lap in edge metal.**  
This failed condition was observed in approximately 30 locations.

- Troubleshoot & repair **20 failed patches and flashing conditions** on all roof sections.
- Troubleshoot & repair **30 failed patches over edge metal laps** on all roof sections.
- For penetrations and failed coverstrip/flashing:
  - Clean roof surface with high grade cleaner
  - Apply peel and stick Uni-Bond 6" tape to penetration or seam
  - Apply White Knight Plus WC to Uni-Bond tape and extend coating 4" past all seams of tape. Ensure felt backing of tape is fully saturated.
- Apply GreenLock Structural Adh at termination bars.
- All debris will be cleared up and removed.

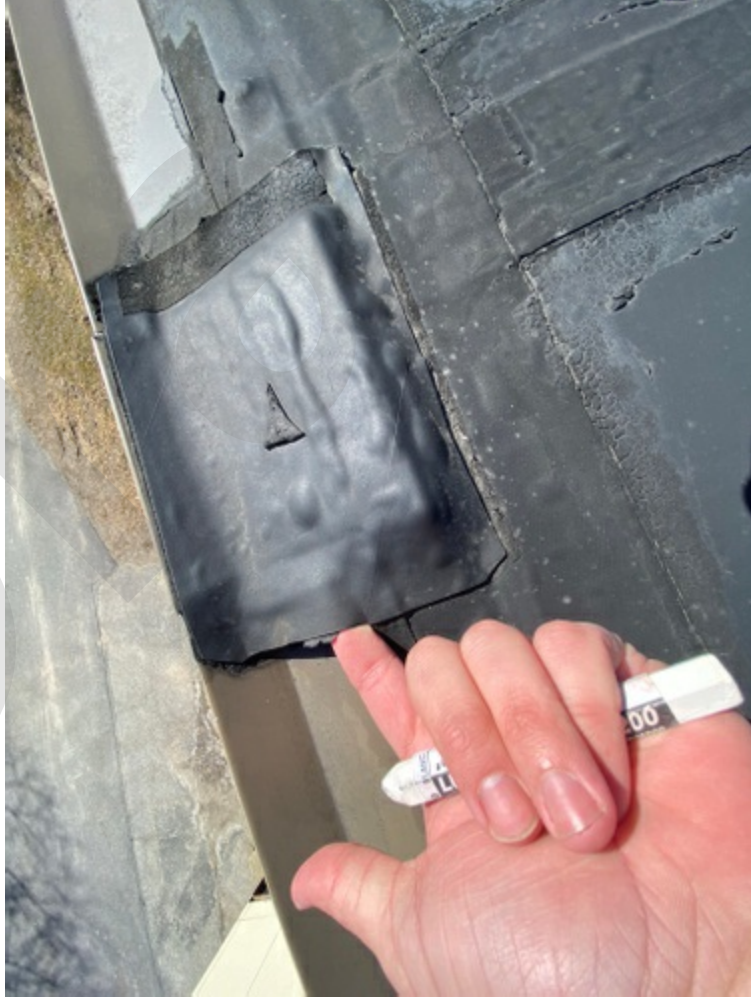
*Photo 10*

**Failed patch over lap in edge metal.**  
This failed condition was observed in approximately 30 locations.

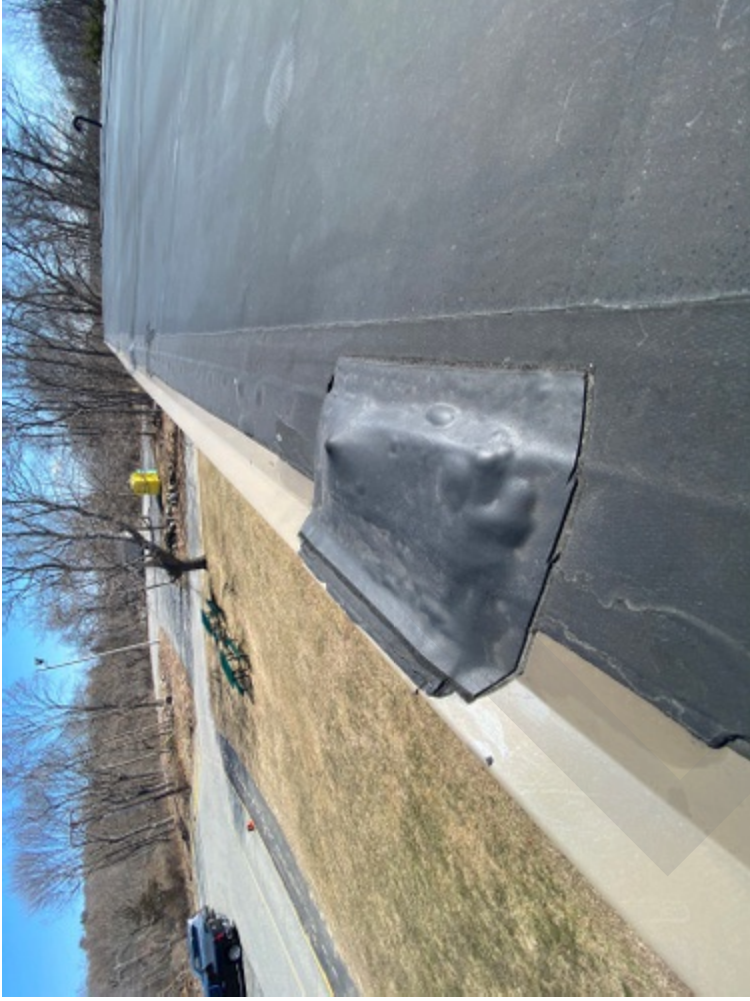
*Photo 11*

**Failed patch over lap in edge metal.**  
This failed condition was observed in approximately 30 locations.

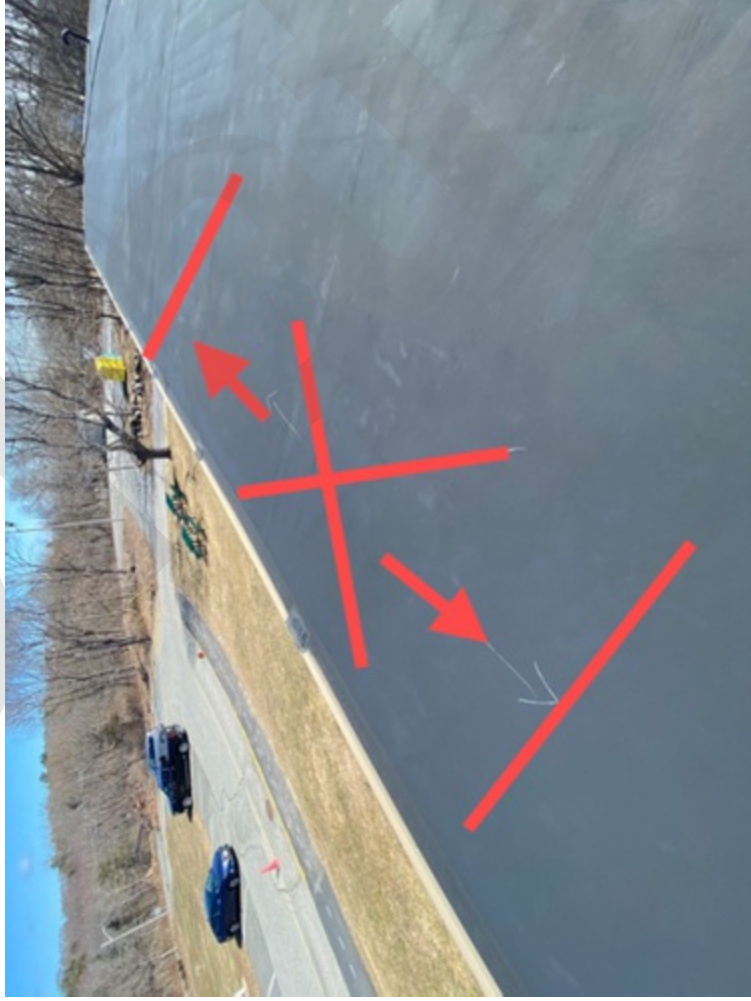
*Photo 12*

**Area of delaminated membrane from insulation.**

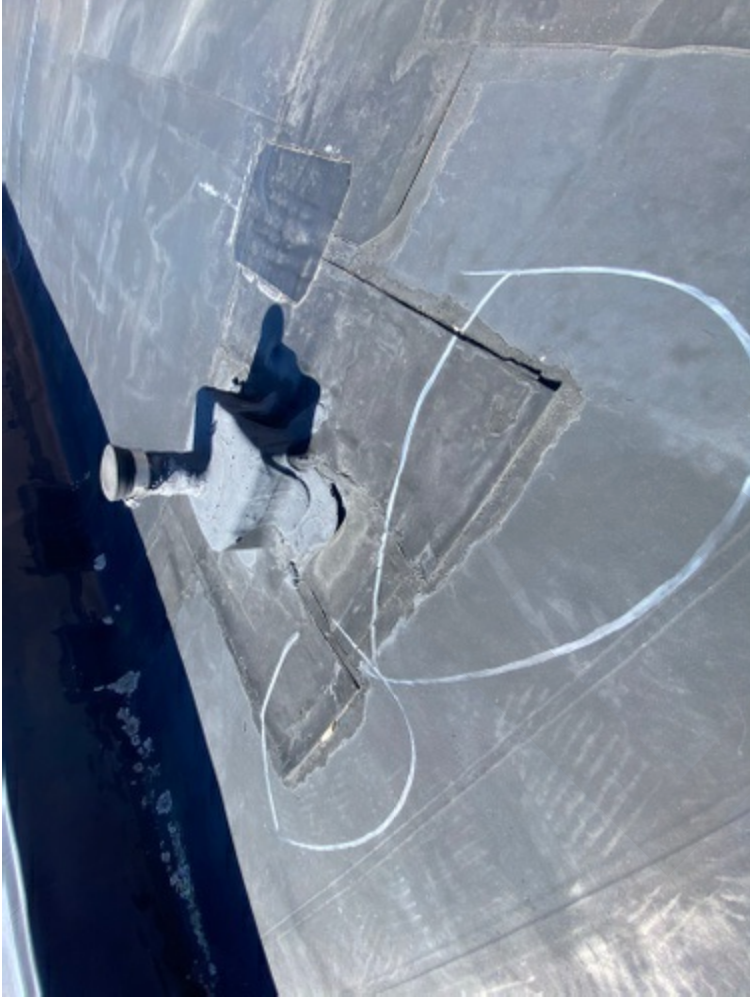
*Photo 15*

**Failed flashing around pitch pocket.**

- Interior water damage
- Mold/Mildew
- Saturated insulation
- resulting in loss of dimensional stability and R Value
- Delamination of the membrane from sub-straight.
- Rust/rot of fasteners and decking

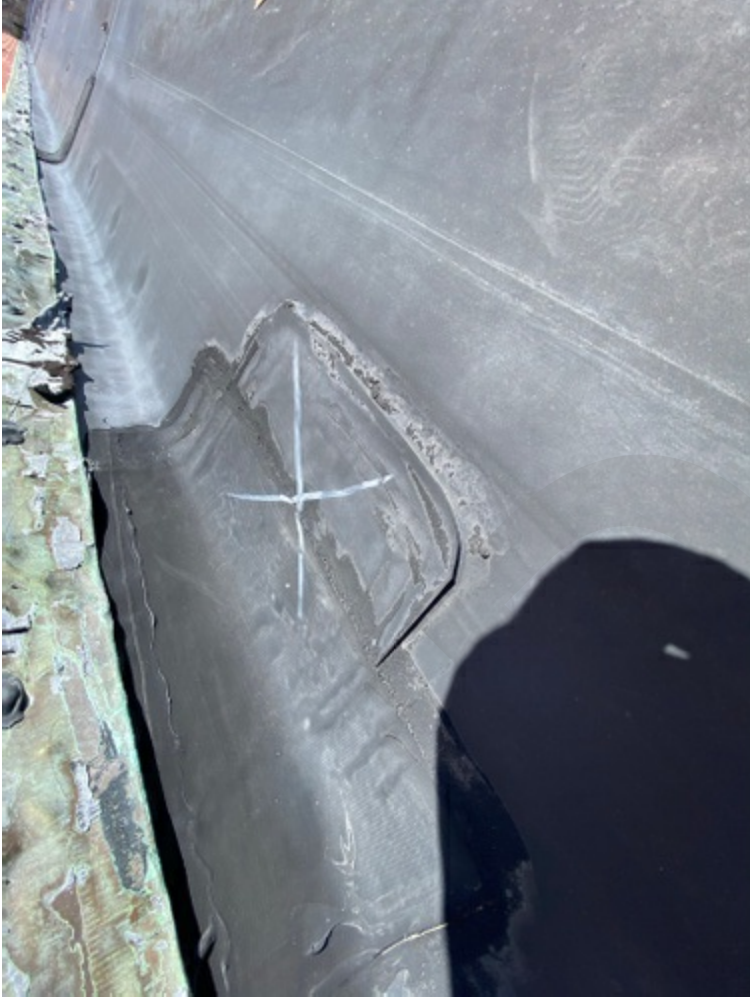
*Photo 19*

**Failed flashing.**

- Interior water damage
- Mold/Mildew
- Saturated insulation resulting in loss of dimensional stability and R Value
- Delamination of the membrane from sub-straight.
- Rust/rot of fasteners and decking

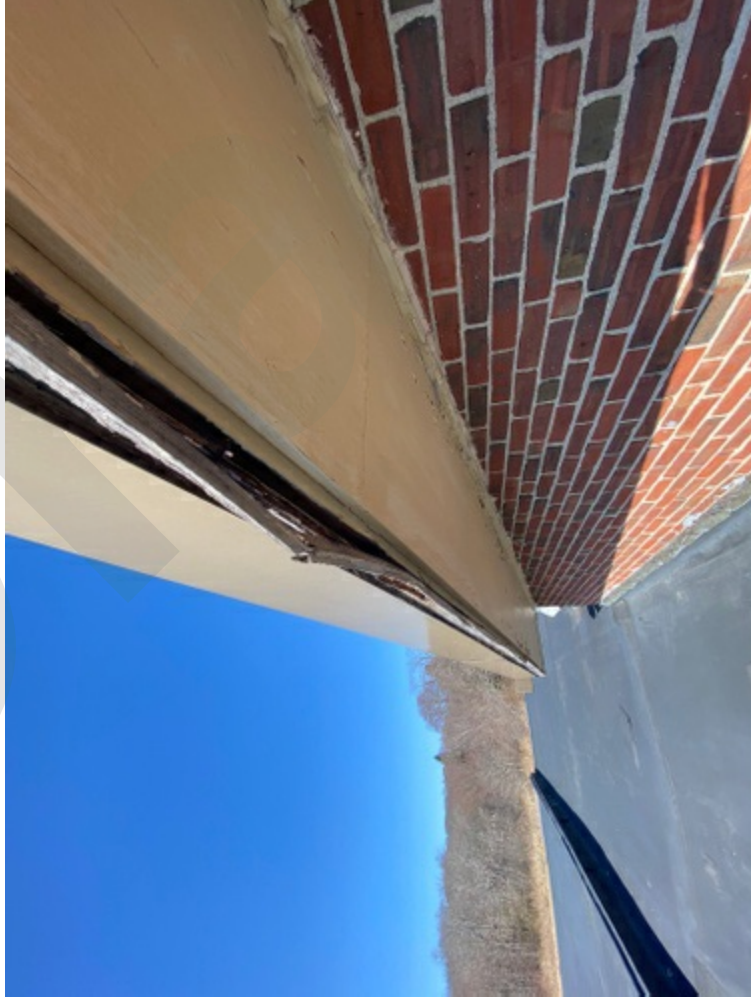
*Photo 20*

**Rotted fascia board under edge metal.**

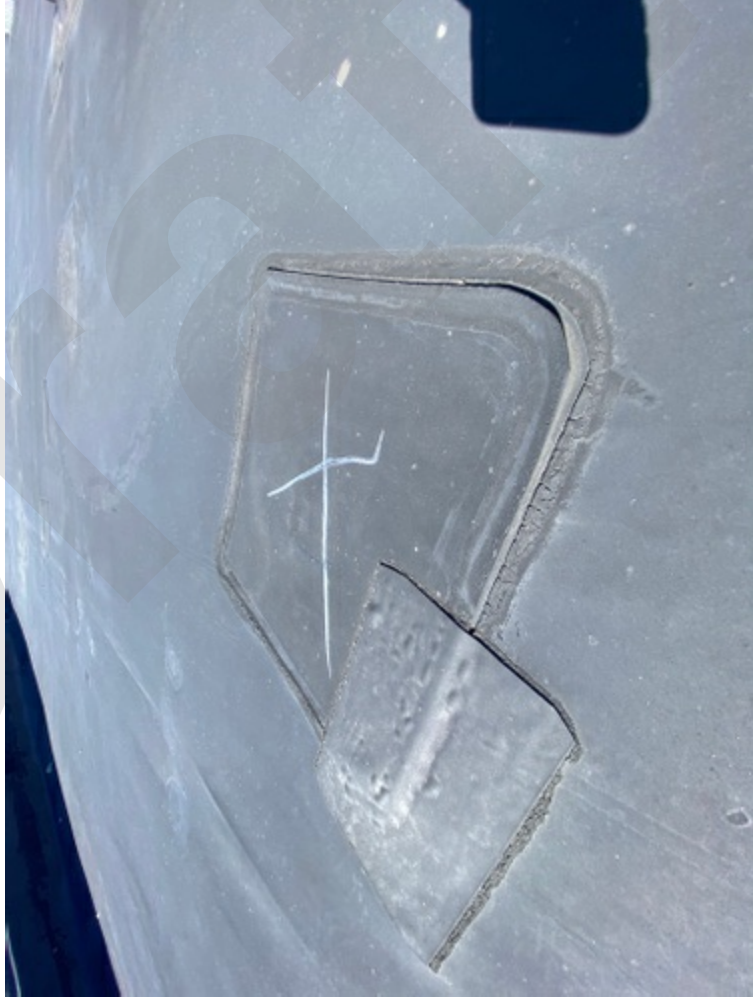
Photo 22

**Failed patch.**

- Interior water damage
- Mold/Mildew
- Saturated insulation resulting in loss of dimensional stability and R Value
- Delamination of the membrane from sub-straight.
- Rust/rot of fasteners and decking

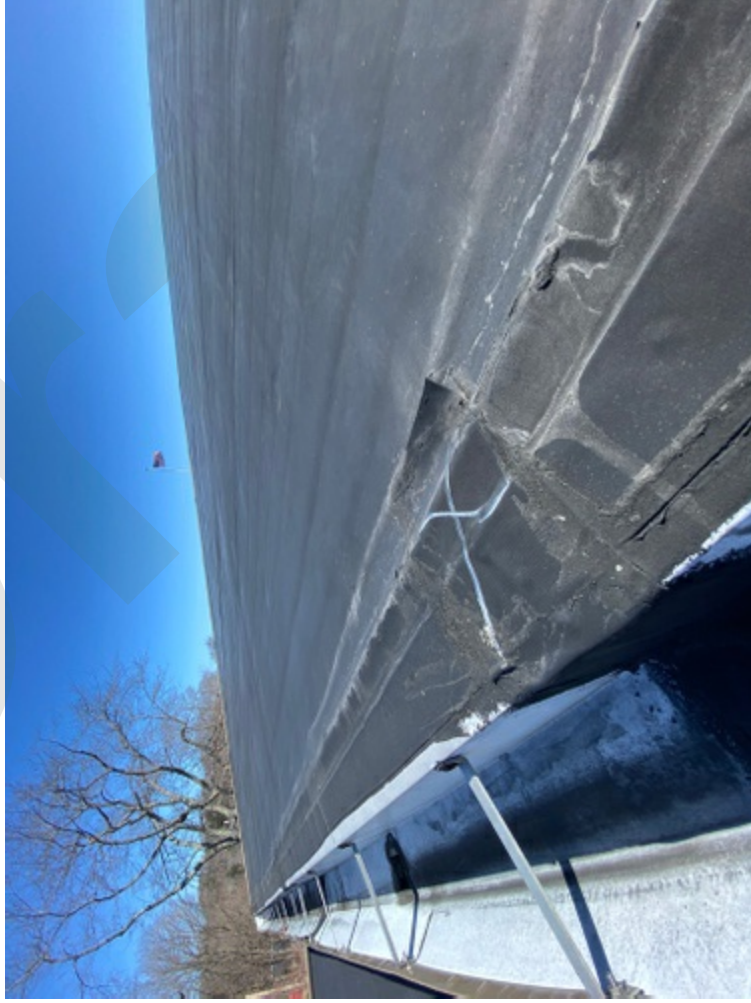
*Photo 24*

**Failed flashing above gutter.**

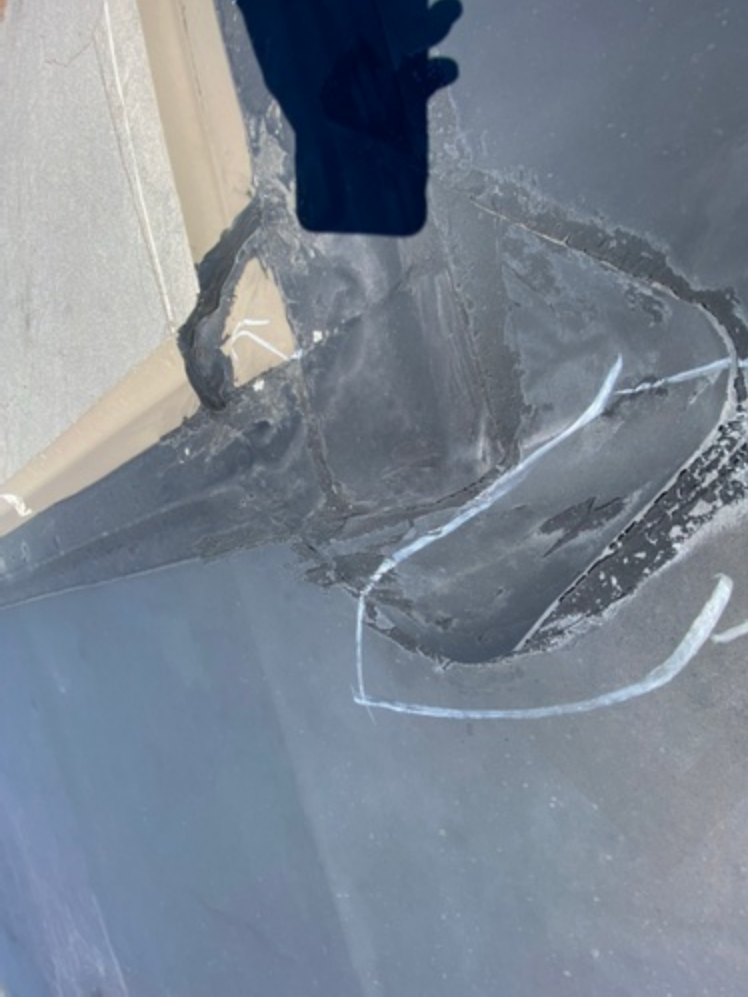
*Photo 25*

**Failed corner flashing.**

- Interior water damage
- Mold/Mildew
- Saturated insulation resulting in loss of dimensional stability and R Value
- Delamination of the membrane from sub-straight.
- Rust/rot of fasteners and decking

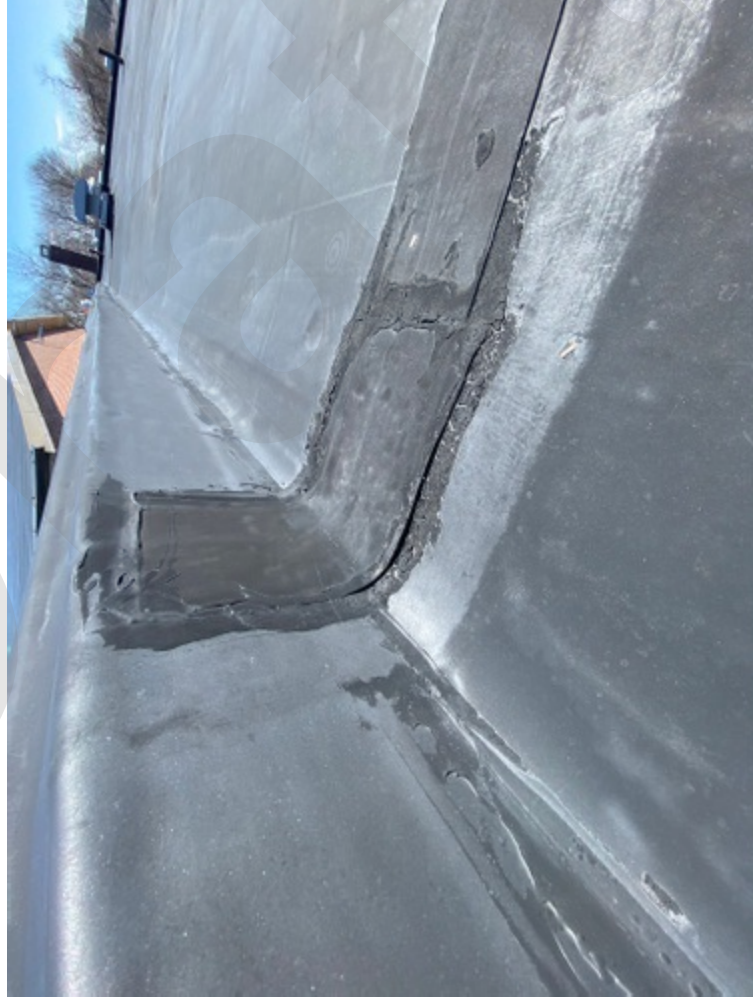
*Photo 26*

**Failed vertical flashing.**

- Interior water damage
- Mold/Mildew
- Saturated insulation resulting in loss of dimensional stability and R Value
- Delamination of the membrane from sub-straight.
- Rust/rot of fasteners and decking

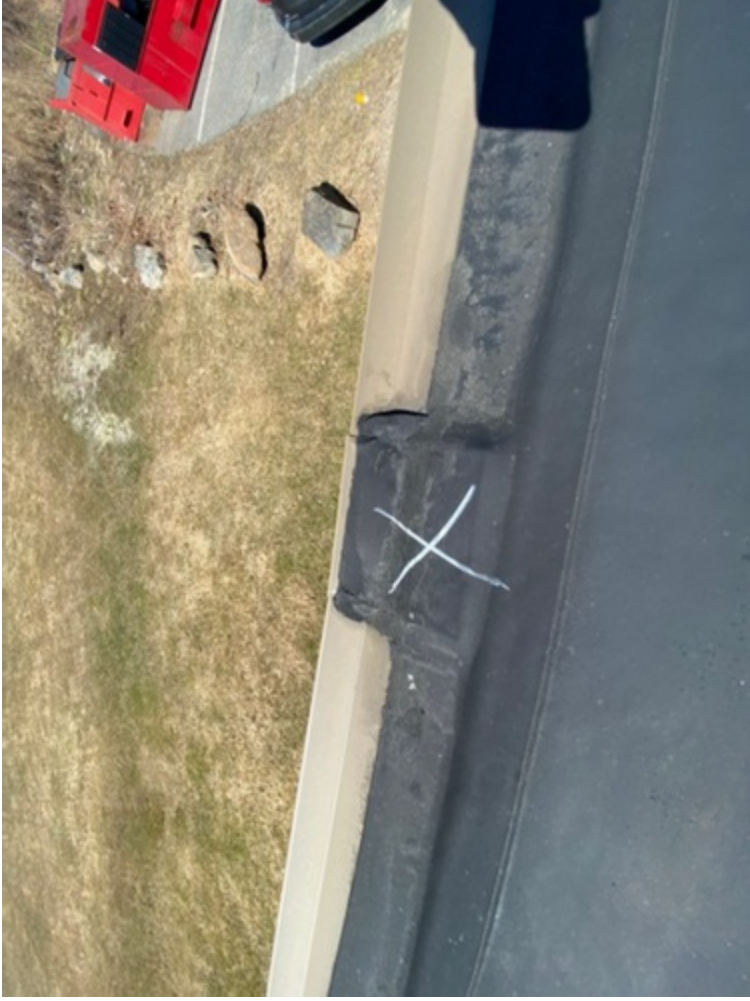
*Photo 27*

**Failed patch over lap in edge metal.**

This failed condition was observed in approximately 30 locations.

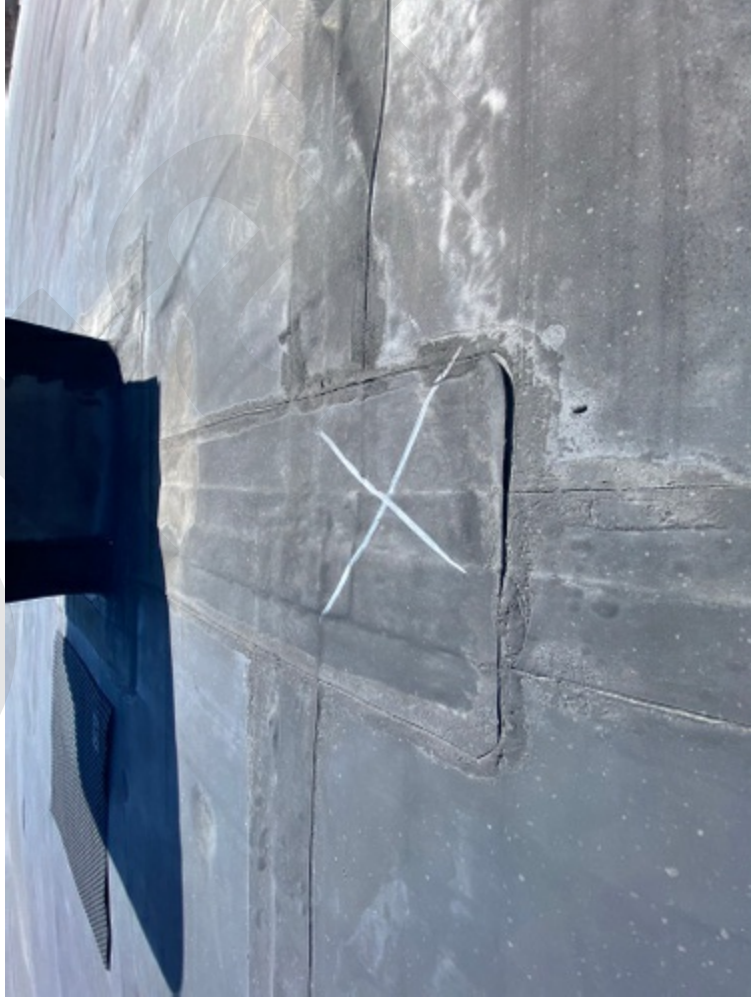
*Photo 28*

**Failed patch.**

- Interior water damage
- Mold/Mildew
- Saturated insulation resulting in loss of dimensional stability and R Value
- Delamination of the membrane from sub-straight.
- Rust/rot of fasteners and decking

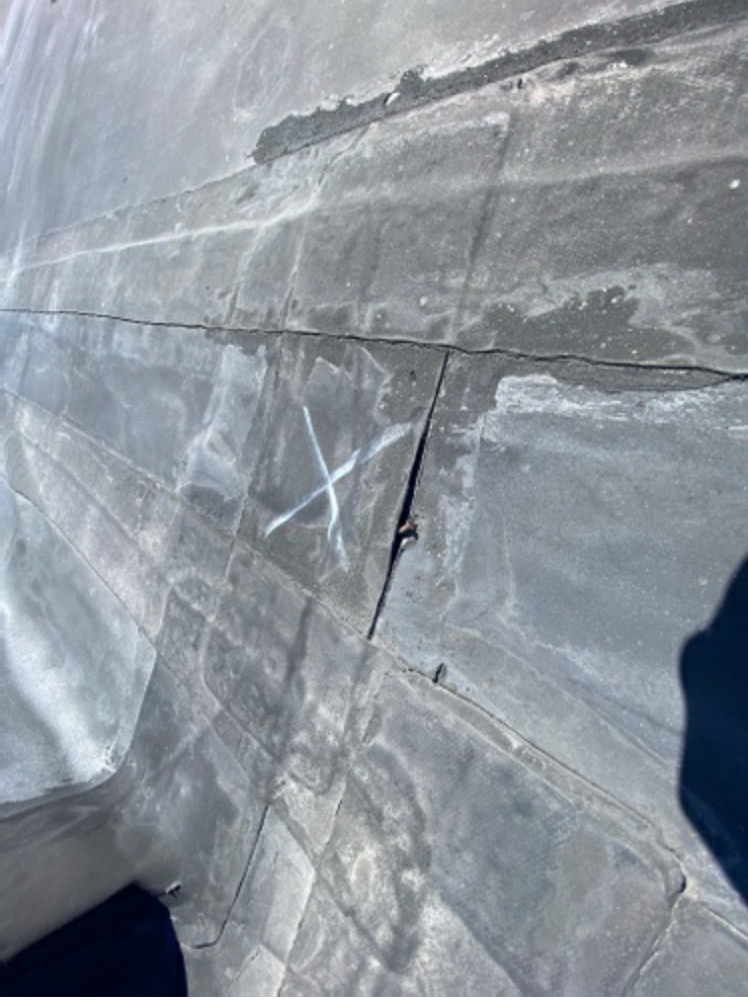
*Photo 29*

**Failed patch.**

- Interior water damage
- Mold/Mildew
- Saturated insulation resulting in loss of dimensional stability and R Value
- Delamination of the membrane from sub-straight.
- Rust/rot of fasteners and decking

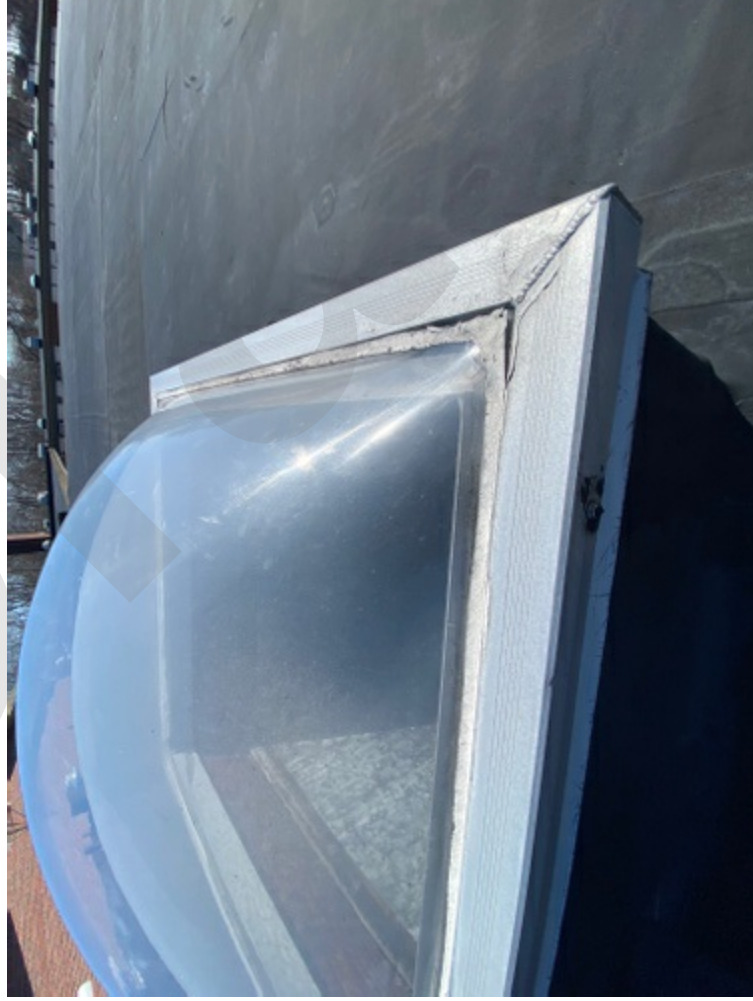
*Photo 30*

**Deteriorated sealant around skylight.**
