## FACILITY NEEDS ASSESSMENT

### ESSEX ELEMENTARY SCHOOL AND MANCHESTER ESSEX MIDDLE-HIGH SCHOOL

#### Manchester Essex Regional School District

DRAFT REPORT: January 27, 2023  
H&A JN 2217.01

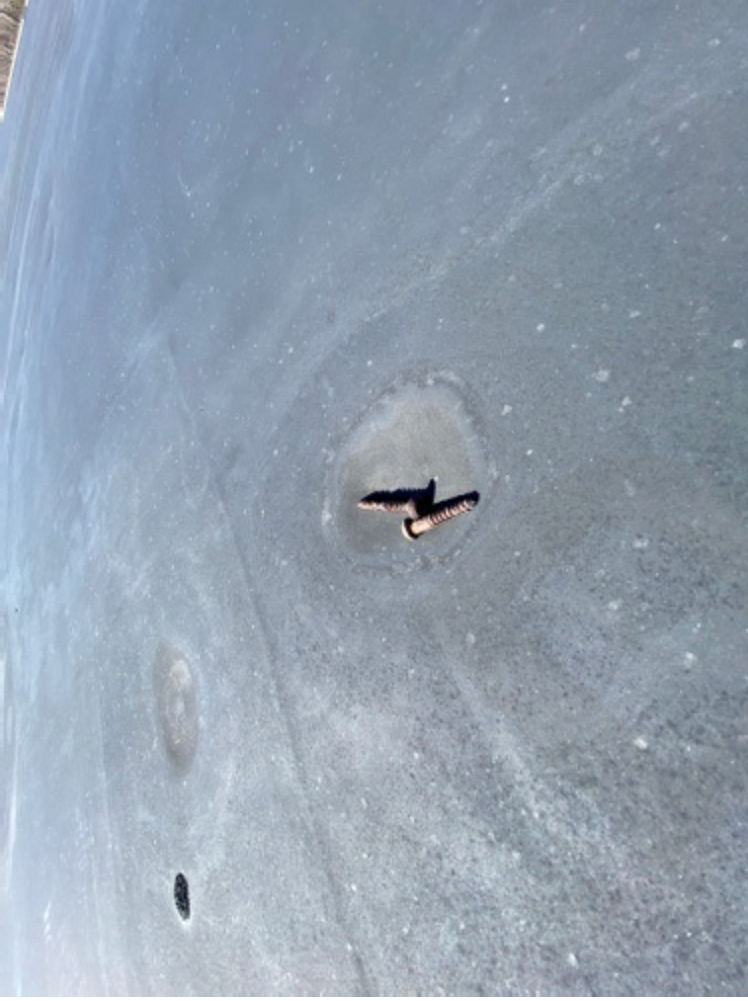
*Photo 31*

**Fasteners were observed around the roof.**  
These are potential puncture points in the membrane.

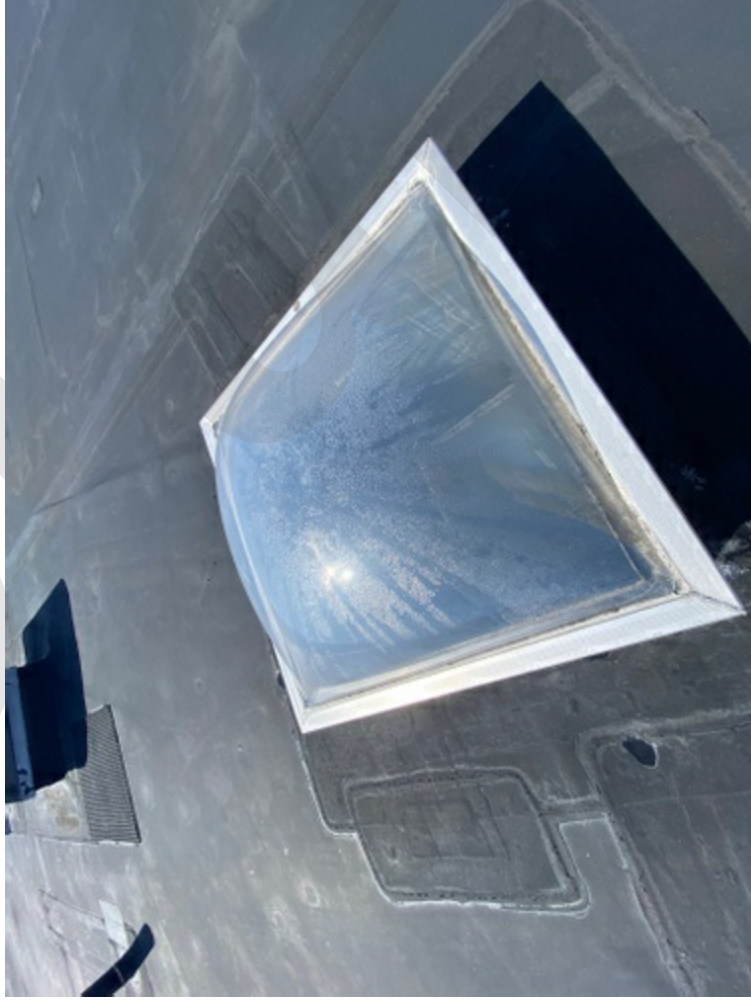
*Photo 32*

**Condensation was observed between the layers of the skylight.**  
This is a sign of end of life cycle.

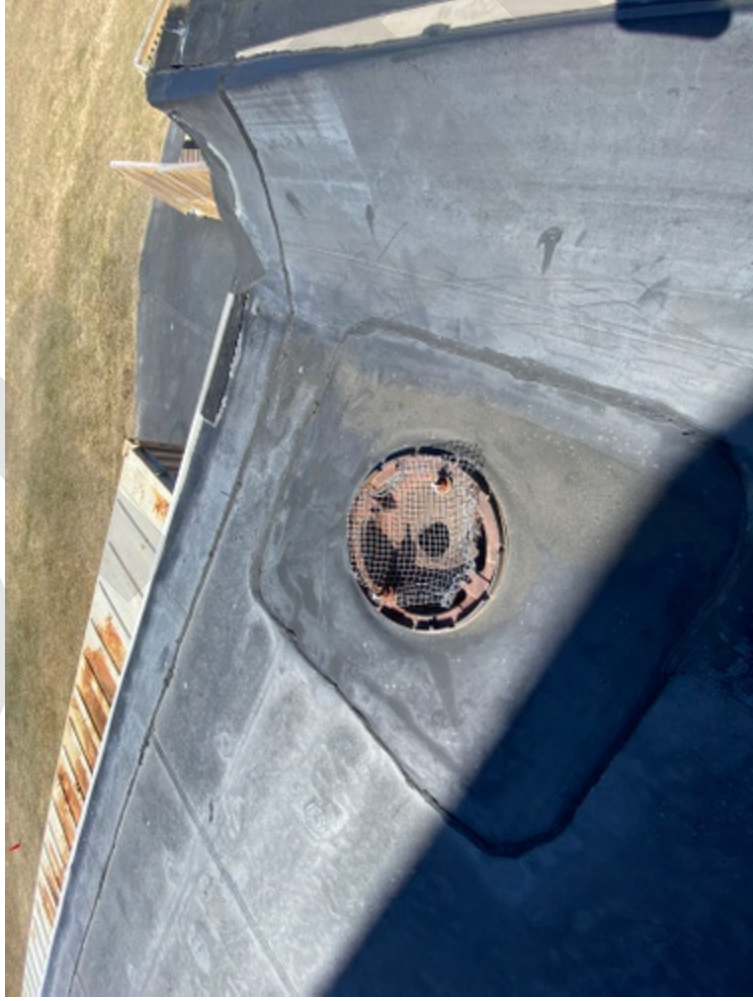
*Photo 34*

**Missing drain basket.**

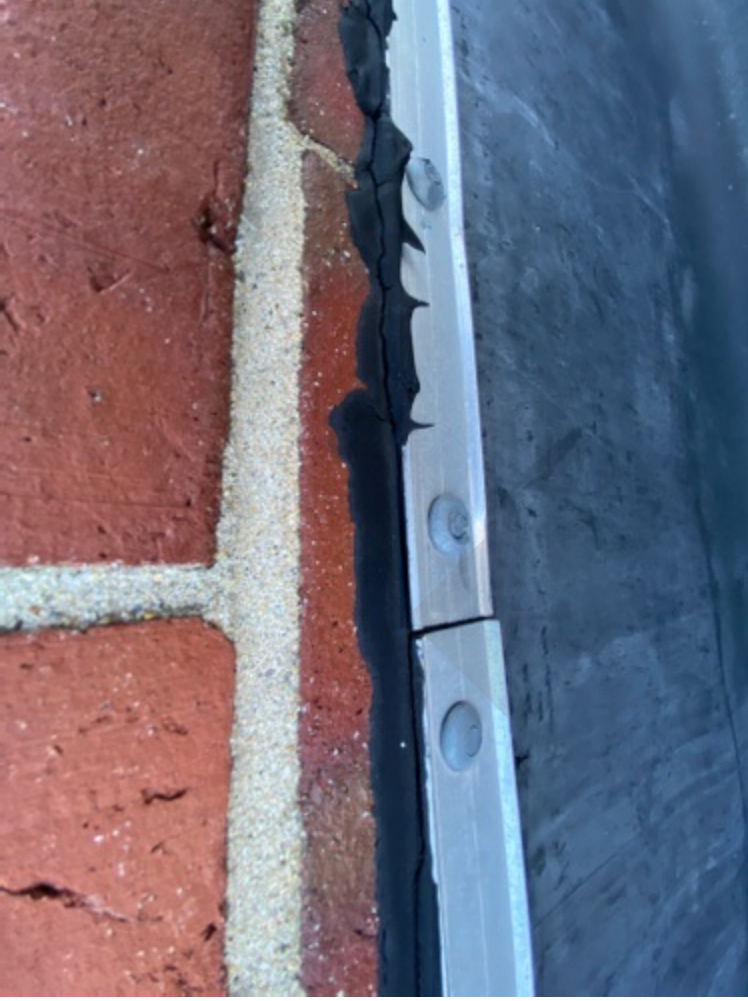
*Photo 35*

**Deteriorated sealant above surface mounted termination bar.**

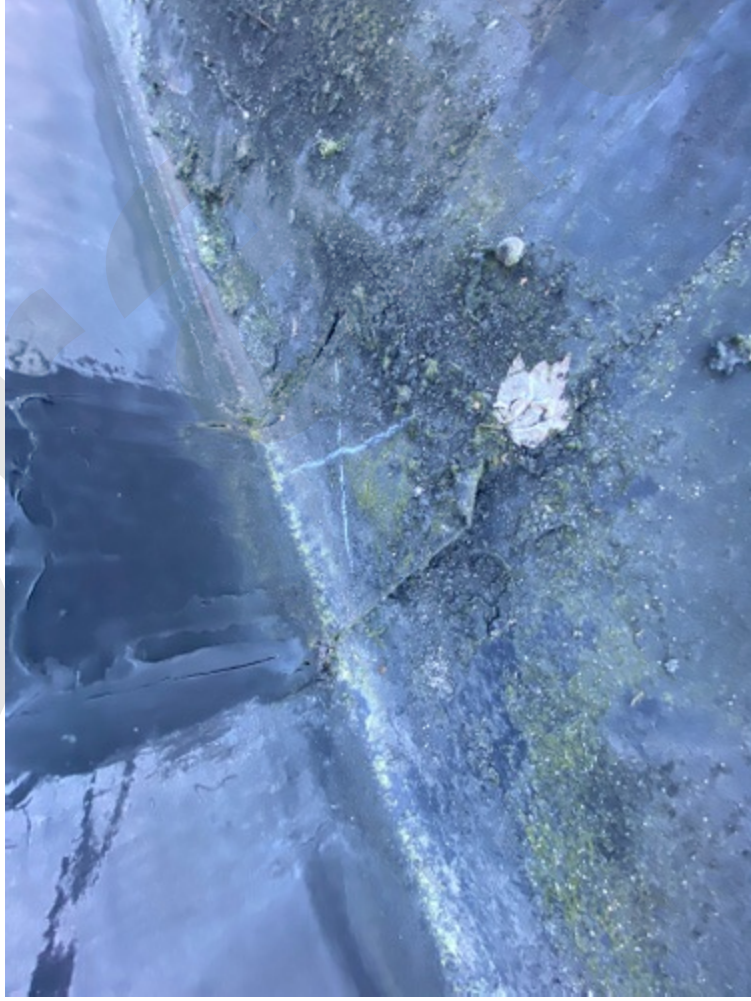
*Photo 36*

**Failed patch.**

- Interior water damage
- Mold/Mildew
- Saturated insulation resulting in loss of dimensional stability and R Value
- Delamination of the membrane from sub-straight.
- Rust/rot of fasteners and decking

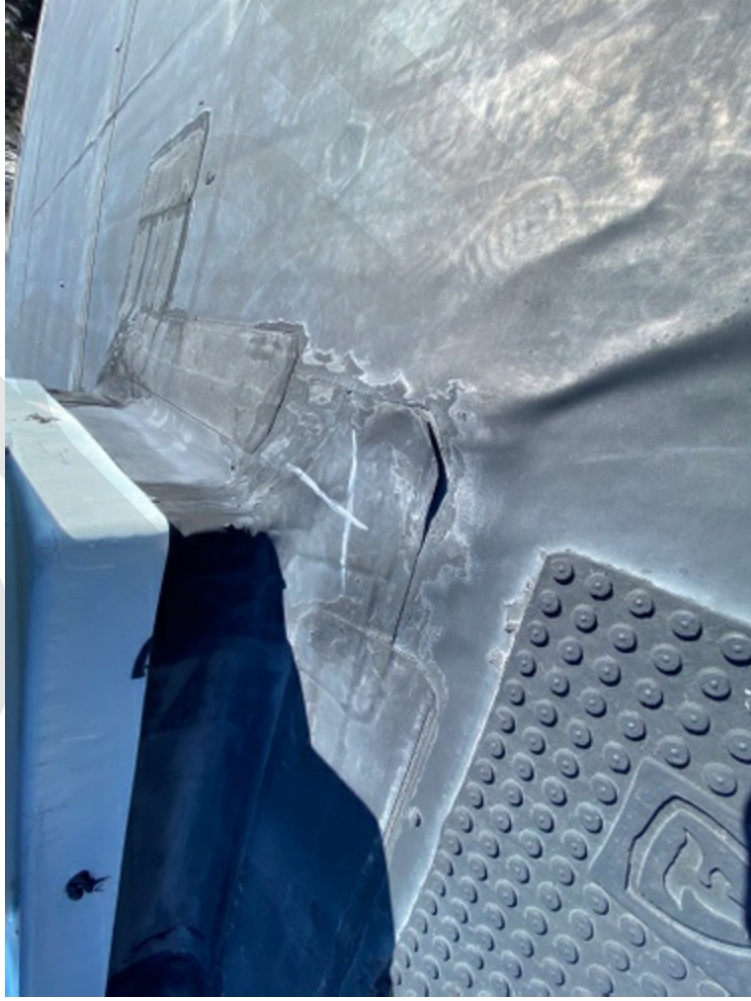
Photo 38

**Failed patch.**
