# ON-SITE TESTING PERMEABILITY & PLANARITY

<b>Project Name</b>	Manchester Essex Regional Middle High School Hyland Field EN 12616:2013 Permeability Evaluation		
<b>Client Info</b>	SprinTurf 146 Fairchild St, Suite 150 Daniel Island, SC 29492	<b>Site Info</b>	Manchester Essex Regional Middle High School 36 Lincoln St Manchester-by-the-Sea, MA 01944
<b>Report Date</b>	8/22/2023	<b>Test Date</b>	8/17/2023, 8/19/2023
<b>Report Status</b>	Final	<b>Job No.</b>	98801/8993s
<b>Prepared by</b>	Michael Rocheleau Field Operations Manager		
<b>Checked By</b>	Jeffrey Gentile Operations Director

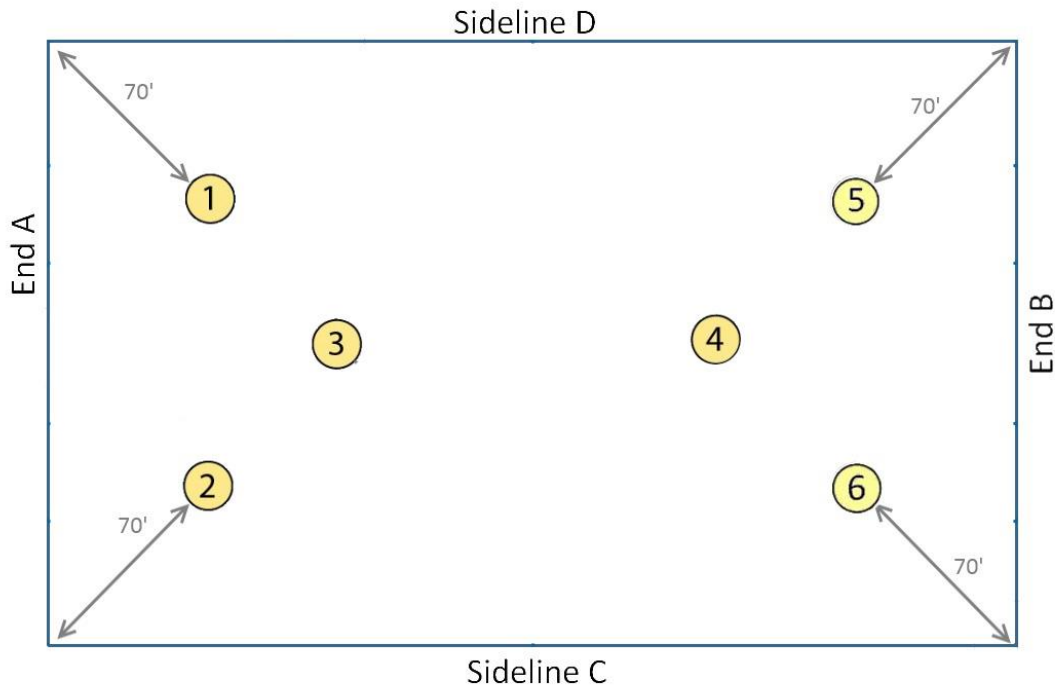
## Permeability Location Map

Location	Permeability Rate (in/hr)
Location #1	17
Location #2	20
Location #3	35
Location #4	41
Location #5	>100
Location #6	73

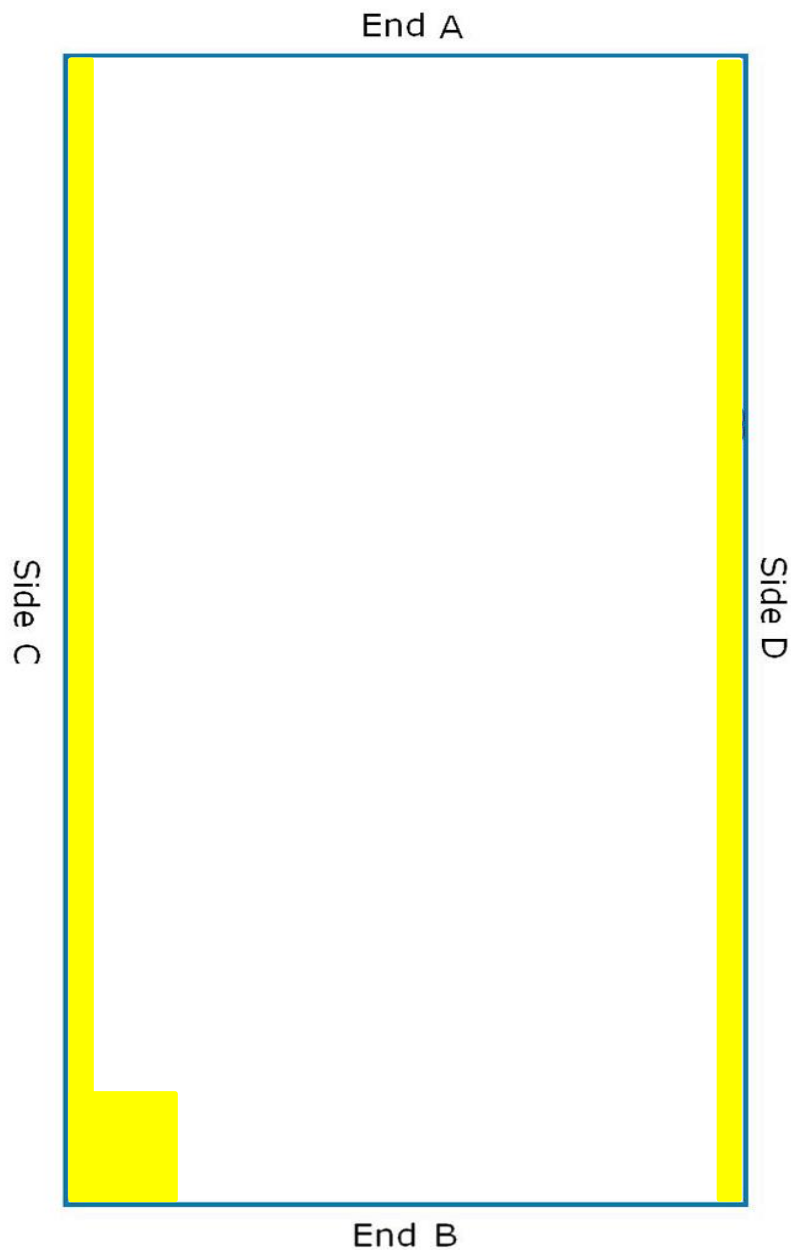
No Deviations Found. Highlighted areas were not complete at time of testing.
