HABEEB & ASSOCIATES
ARCHITECTS

FACILITY NEEDS ASSESSMENT

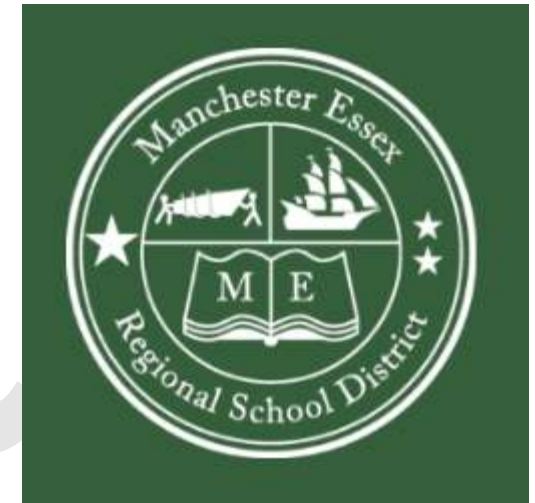
Based on the result of the facility condition assessment and the space adequacy assessment we see two Master Plan Options available for the Essex Elementary School.

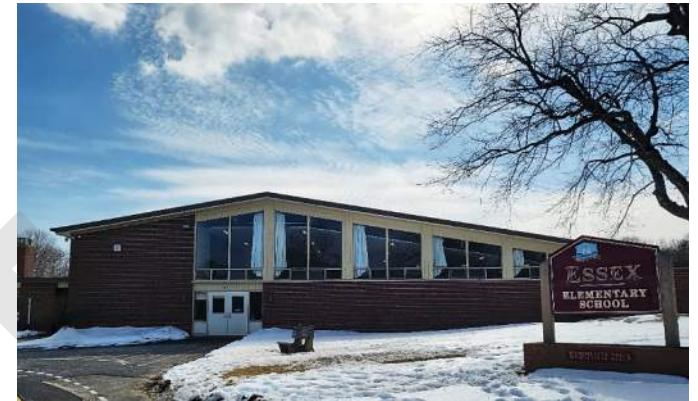
The spreadsheets and photographs included in the FCA detail the recommendations and associated costs for addressing the deficiencies. Estimated costs for projects to be completed in future years contain escalation factors to account for inflation.

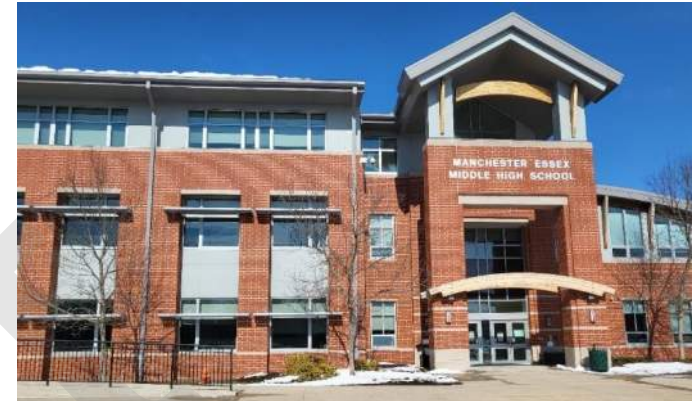
Scope 3 – Does Not Meet Current Codes for new construction but “Grandfathered” OR Recommended (6-10 years)

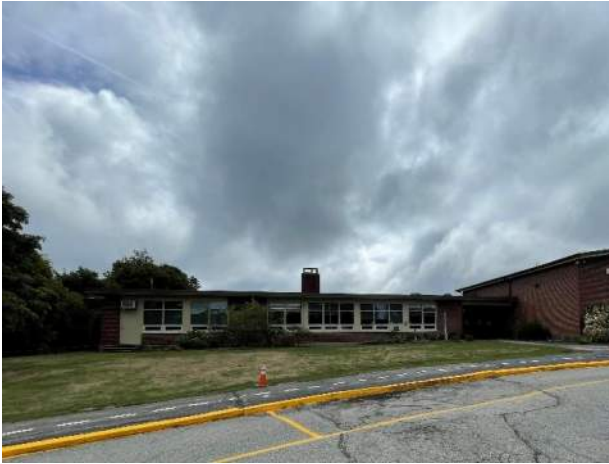
1. Bituminous driveway shows signs of cracking and freeze/thaw damage.

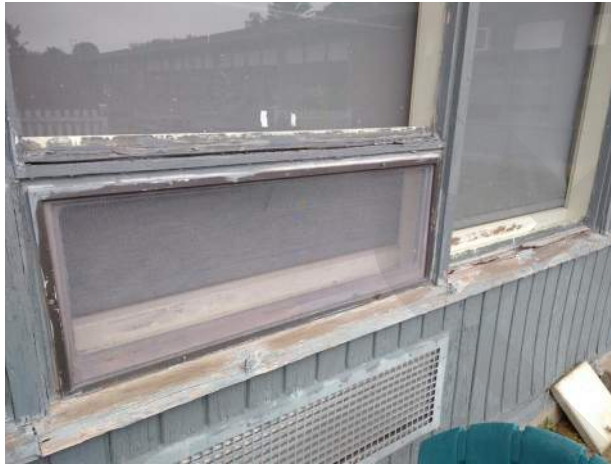
2. Original windows and trim have deteriorated.

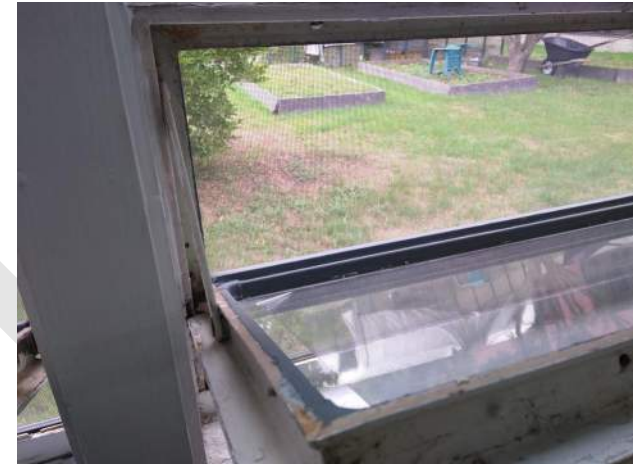
3. Operable steel hopper window has no weather strip.

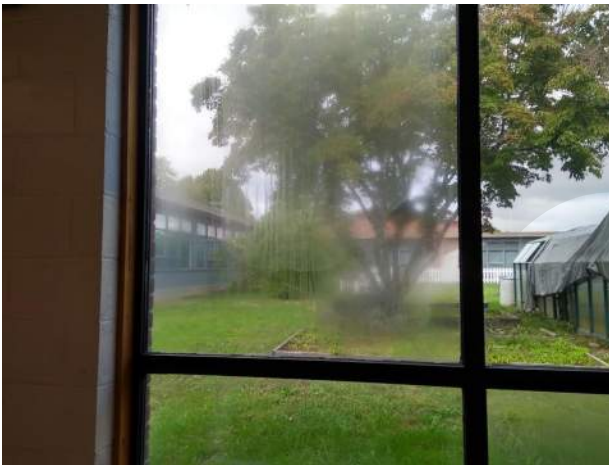
4. Thermal pane window has seal failure.

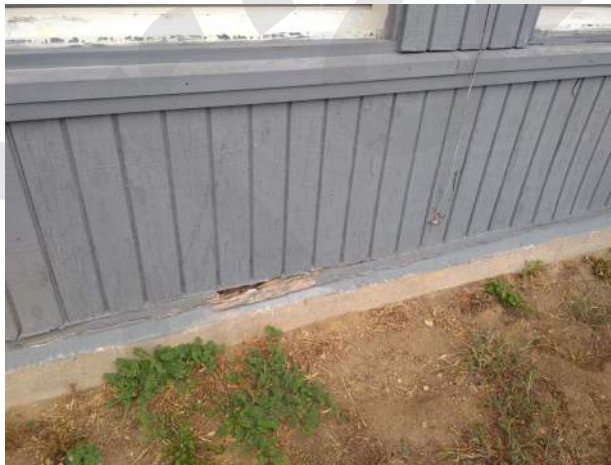
5. The wood siding is rotted and damaged.

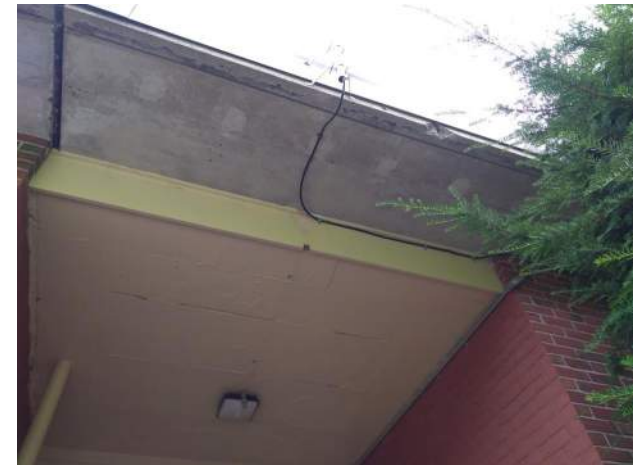
6. The concrete fascias and soffits have spalled.

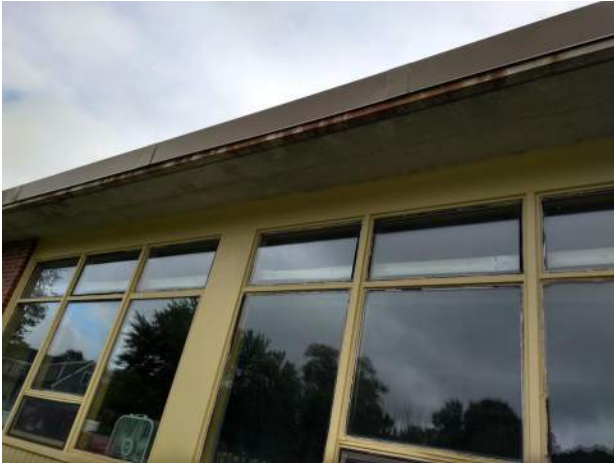
7. Original roof soffits have corroded.

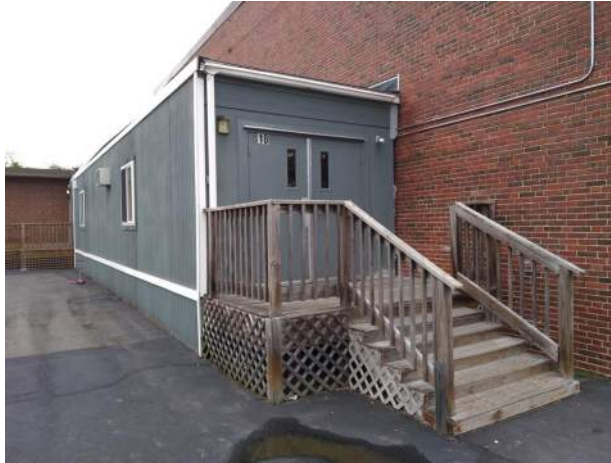
8. Modular addition has deteriorated and leaks at connection to main building.

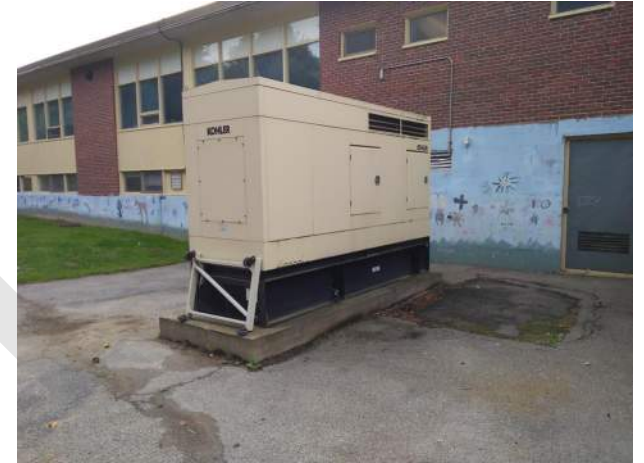
9. Confirm that generator has been maintained per manufacturer's recommendations.

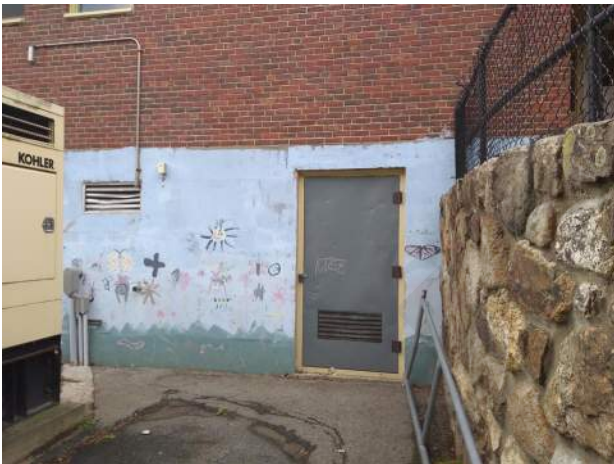
10. Bituminous pavement is damaged, original hollow metal doors require repair/replacement.

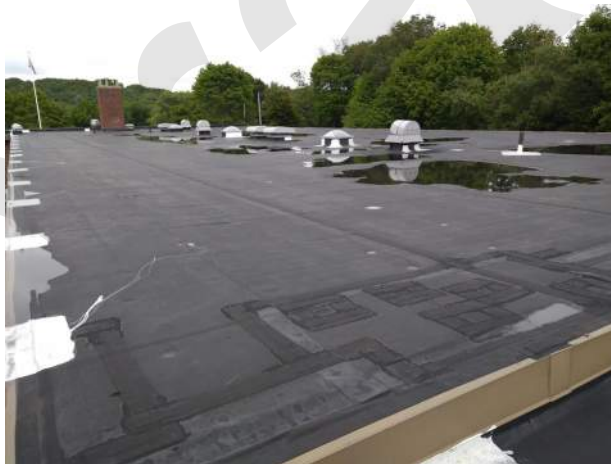
11. Rubber membrane roof has many areas of standing water and is extensively patched.

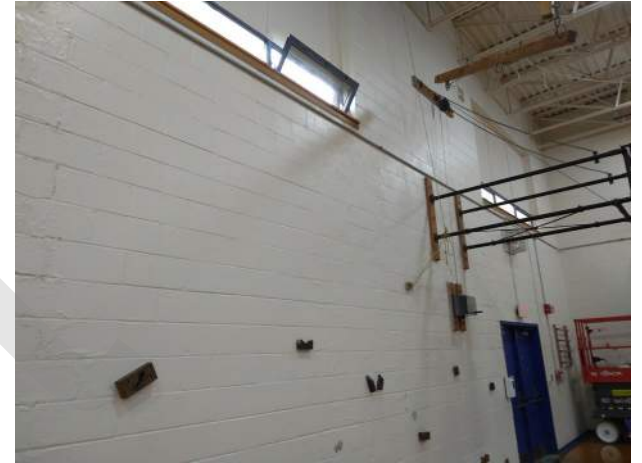
15. The brick/CMU wall of Gym shows signs of extensive water damage and is not insulated.

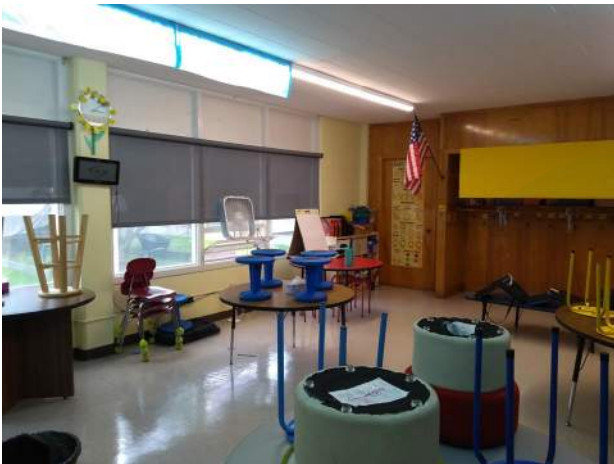
16. Classrooms have outdated spline ceiling and insufficient ventilation.

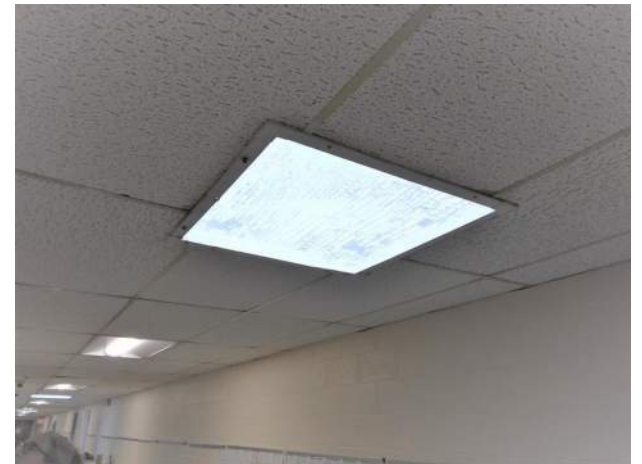
18. The skylights in the corridors are damaged.

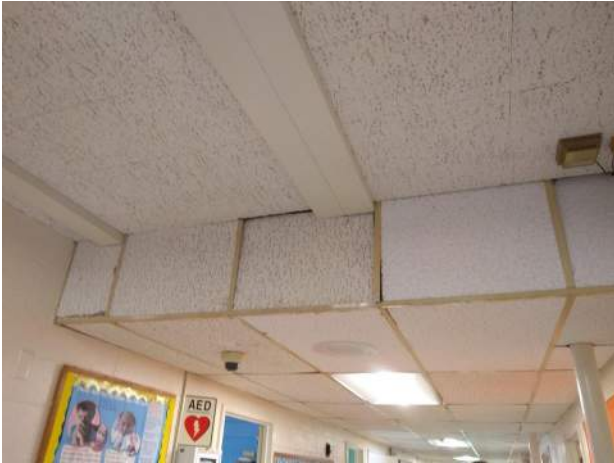
19. Existing 2x4 ceilings are discolored and tiles are mis-matched.

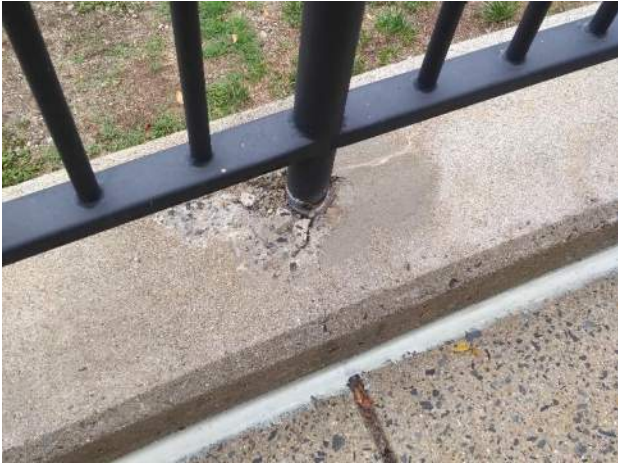
1. Concrete has spalled at some rail posts.

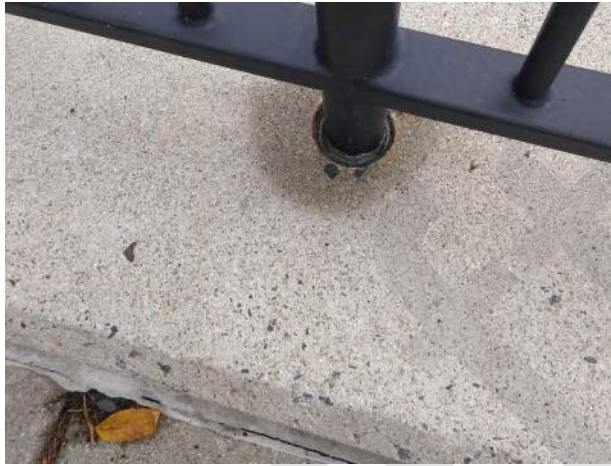
2. Rail posts do not have sealants and some sealants are failing.

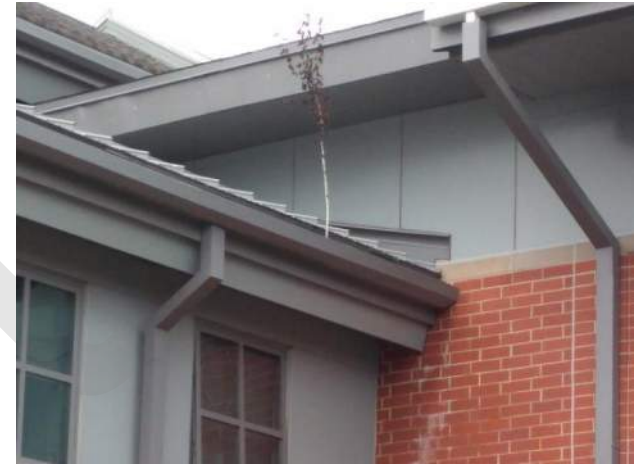
3. Some gutters are clogged with vegetation.

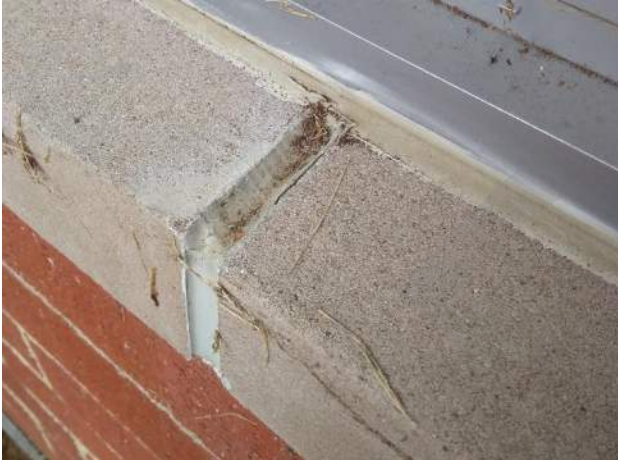
4. Some sealant shows early signs of deterioration.

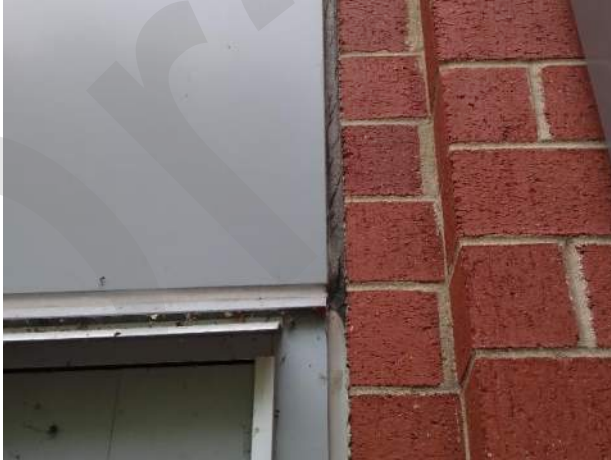
5. Sealant at metal panel is showing signs of deterioration.

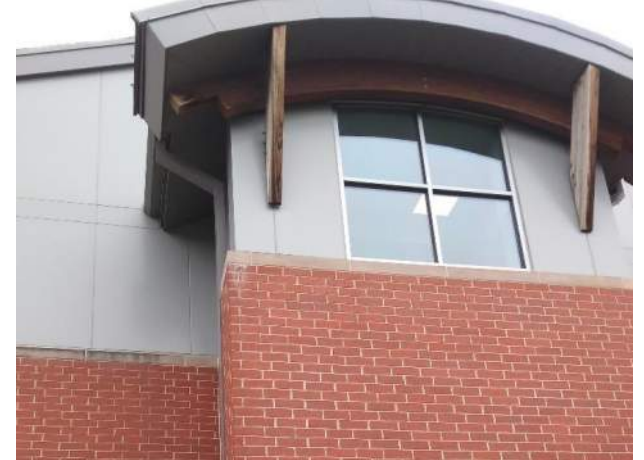
6. Discoloration is evident at wood accents, brick and precast.

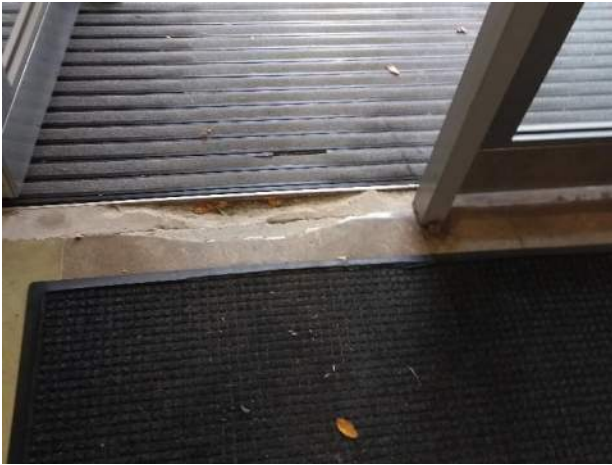
7. Threshold at entry is damaged. Walk off matt is worn.

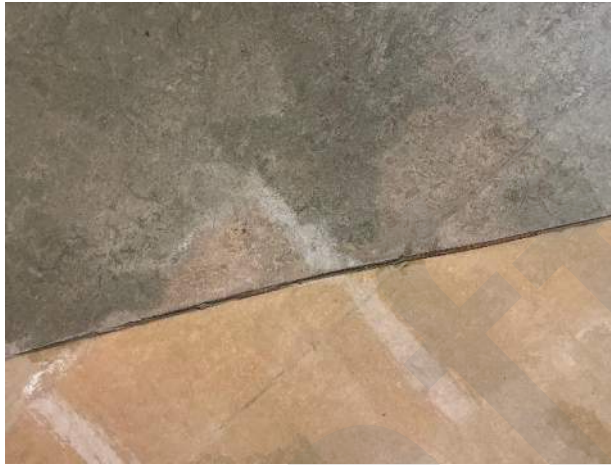
8. Some floor joints at natural linoleum are damaged.

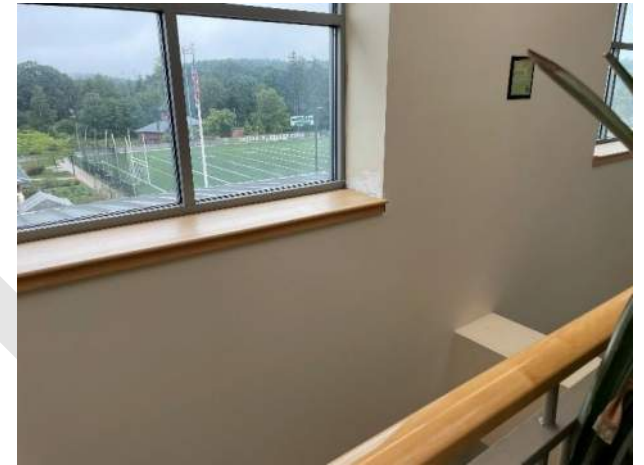
9. Several windows show signs of water damage.

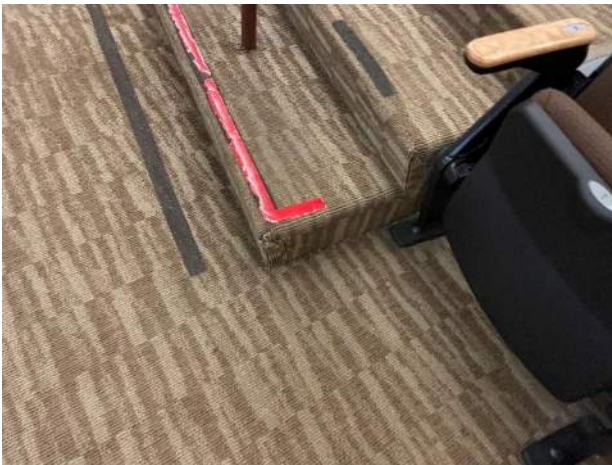
10. Original carpet at Auditorium is showing signs of wear.

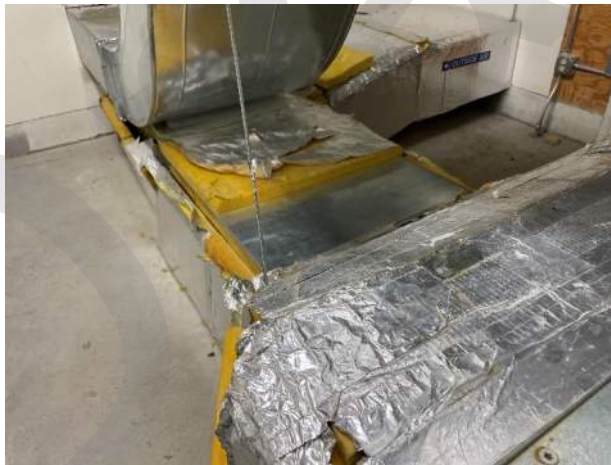
11. Some duct work has damaged or missing insulation.

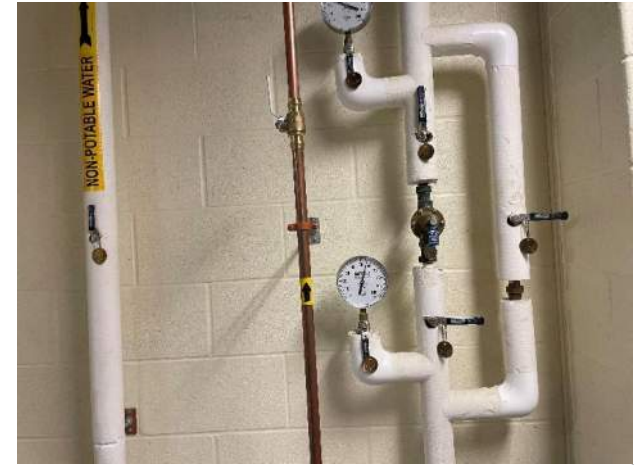
12. Plumbing valves require frequent replacement due to high mineral content in water supply.
