## FACILITY NEEDS ASSESSMENT

### ESSEX ELEMENTARY SCHOOL AND MANCHESTER ESSEX MIDDLE-HIGH SCHOOL

#### Manchester Essex Regional School District

DRAFT REPORT: January 27, 2023  
H&A JN 2217.01

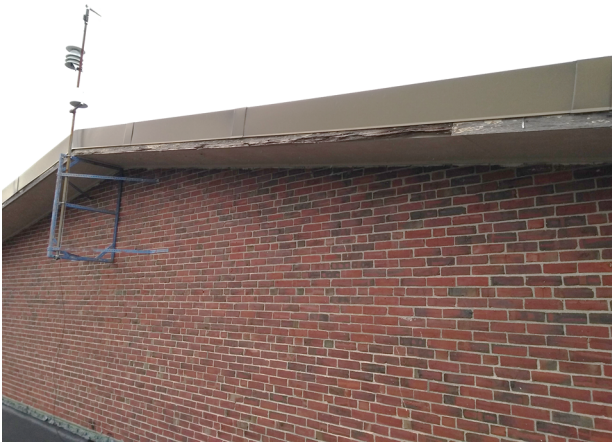
13. The fascia is rotted at the Cafetorium.

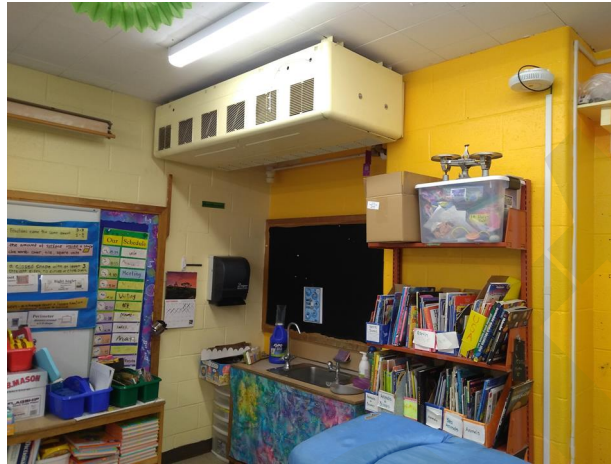
20. Classrooms have outdated and inefficient unit ventilators.

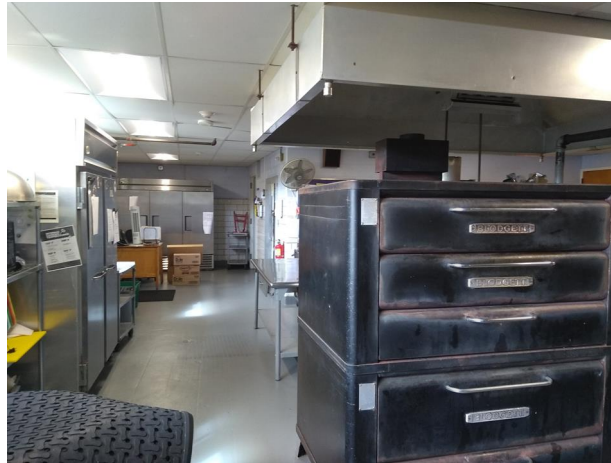
26. Kitchen equipment is very old and inefficient.
