## FACILITY NEEDS ASSESSMENT

### ESSEX ELEMENTARY SCHOOL AND MANCHESTER ESSEX MIDDLE-HIGH SCHOOL

#### Manchester Essex Regional School District

DRAFT REPORT: January 27, 2023  
H&A JN 2217.01

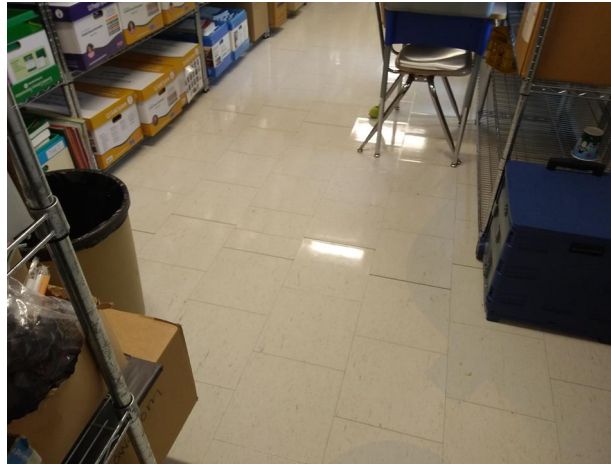
14. Vinyl floor tiles in Modular addition show signs which may indicate issues with subfloor.

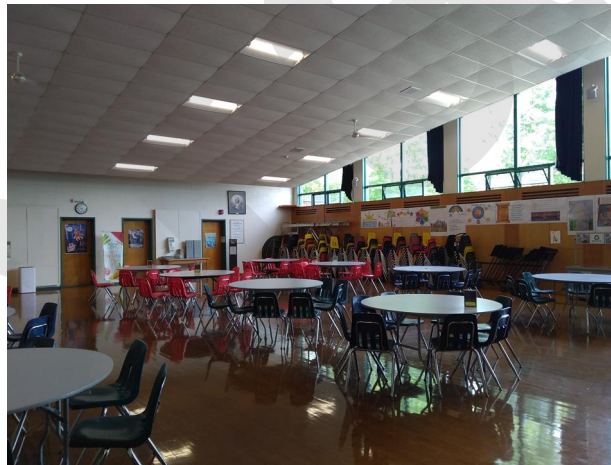
17. Existing 2x4 ceiling tiles have sagged and are cupped.

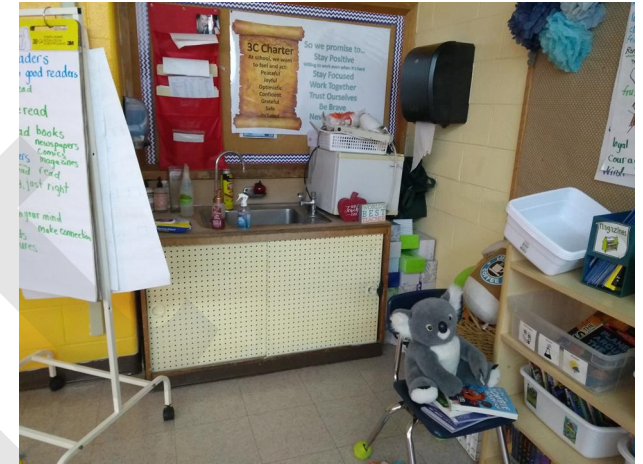
21. Classrooms have outdated sinks that do not meet AAB accessibility requirements.

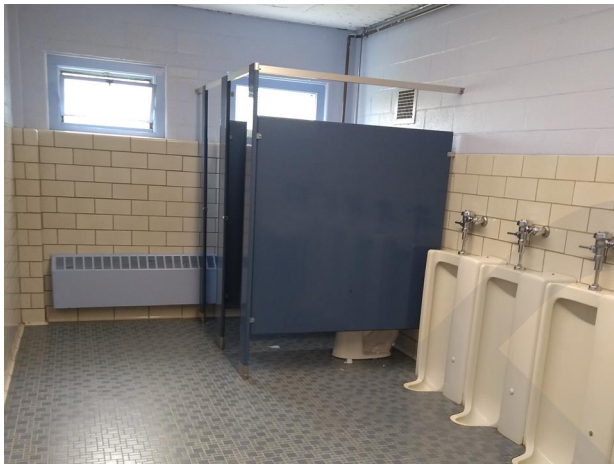
22. Multi-user toilet rooms have original, outdated fixtures and several have no AAB updates.

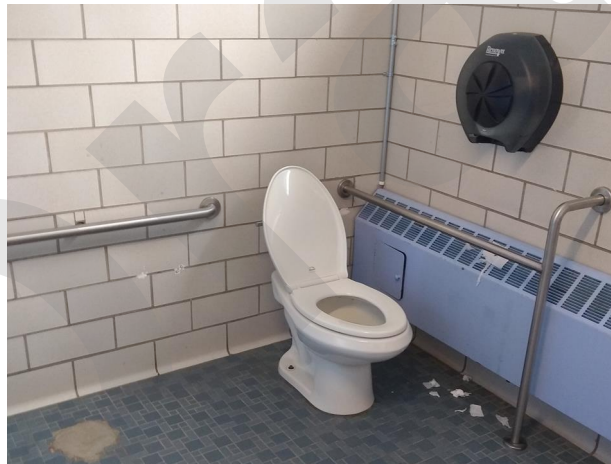
23. Grab bars/accessories are non-compliant and original tile floor is patched.

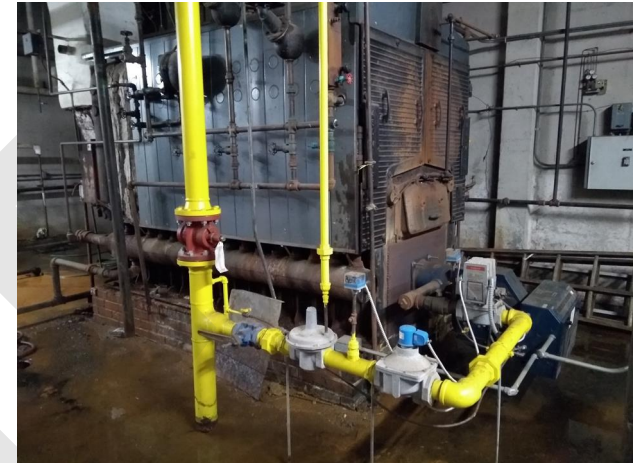
27. This 1975 era boiler is no longer being used.

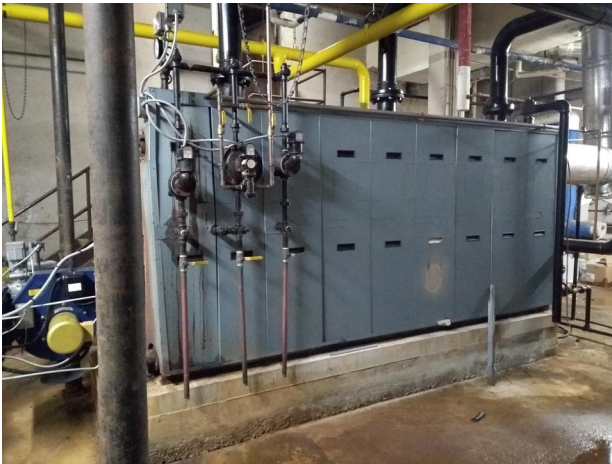
28. This boiler was installed in 2008 and still functions.

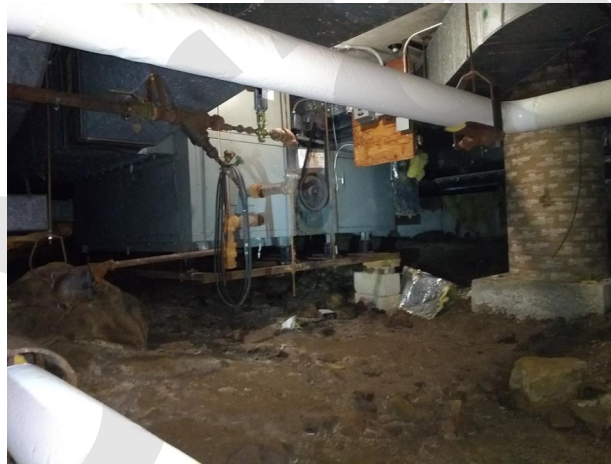
29. This Air Handling Unit in the crawl space is obsolete.

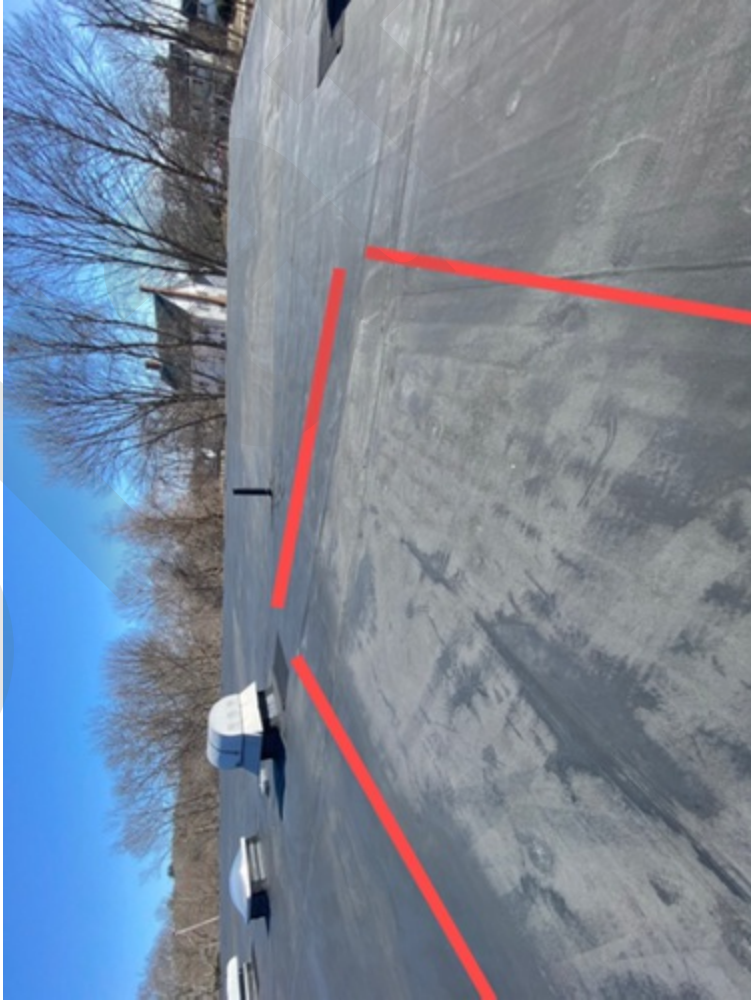
*Photo 2*

**Overview of roof section.**  
"Dirty" area indicates  
ponding water.

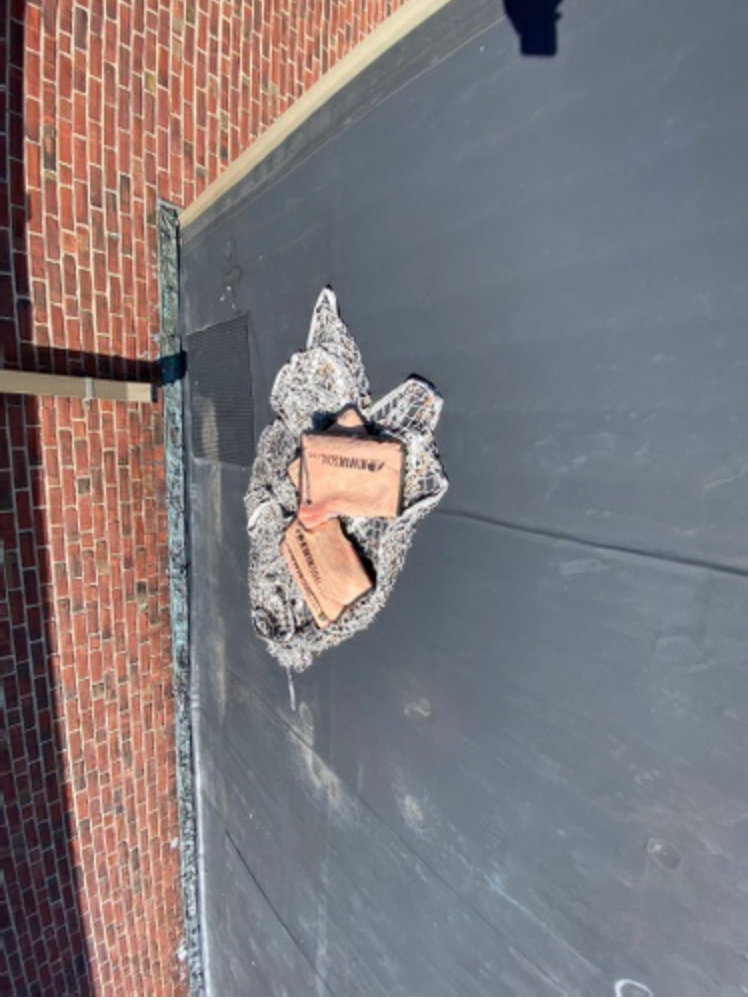
*Photo 13*

**Debris on roof.**

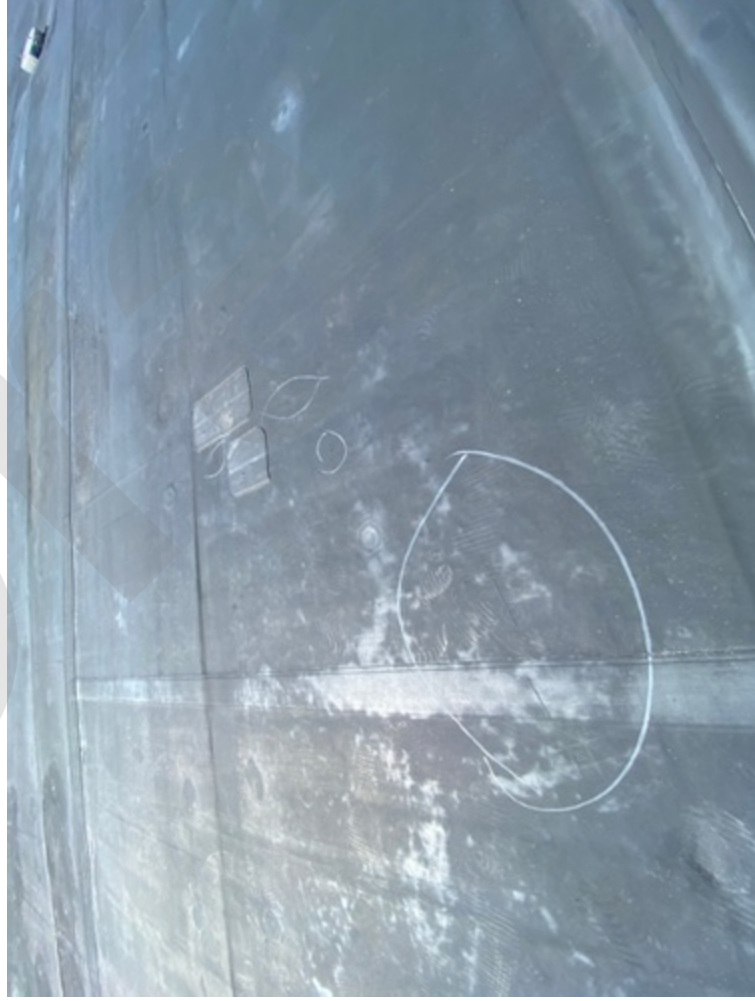
*Photo 14*

**Multiple penetrations observed in membrane.**

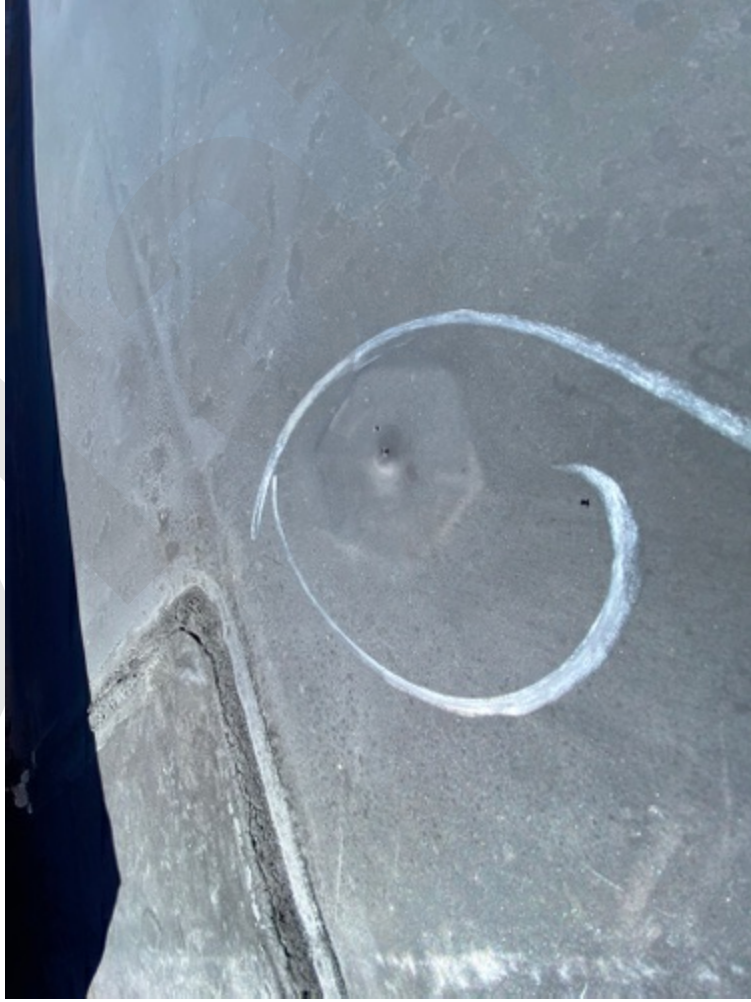
*Photo 18*

**Penetration in membrane  
above fastener location.**

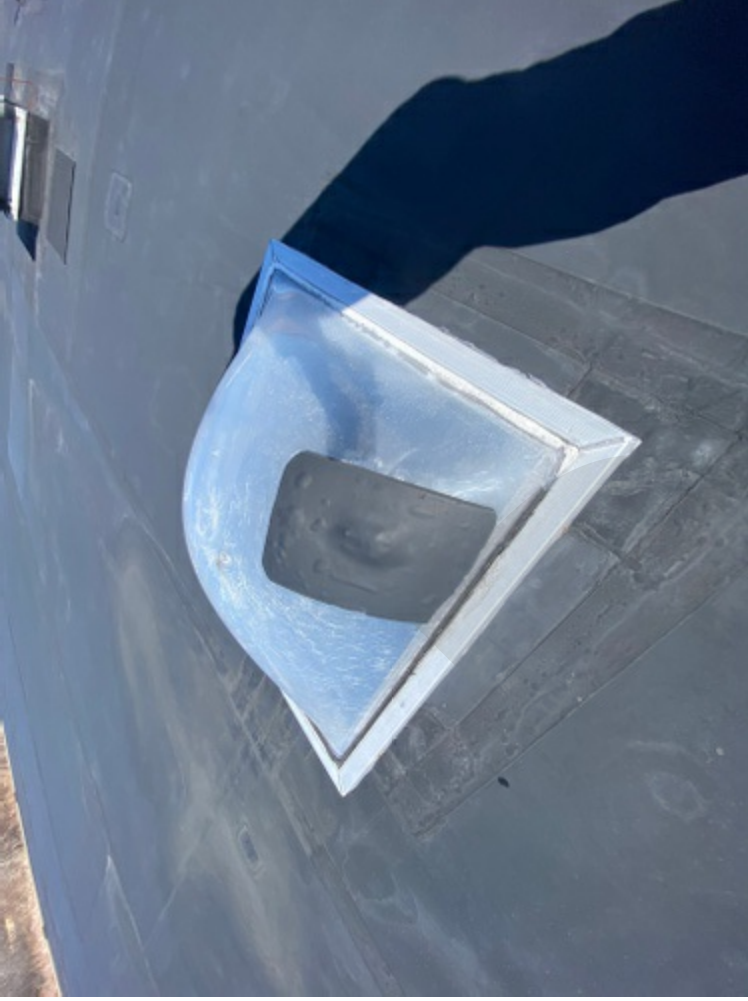
*Photo 33*

**Repaired skylight.**
